The Chimney Doctor Ltd  
2944 I-70 Business Loop #210  
Grand Junction, CO, 81504  
970-234-3330  
info@chimney.doctor  
<https://chimney.doctor>

## SERVICE / INSPECTION REPORT

**Level of Inspection Performed:** Repair of Existing System

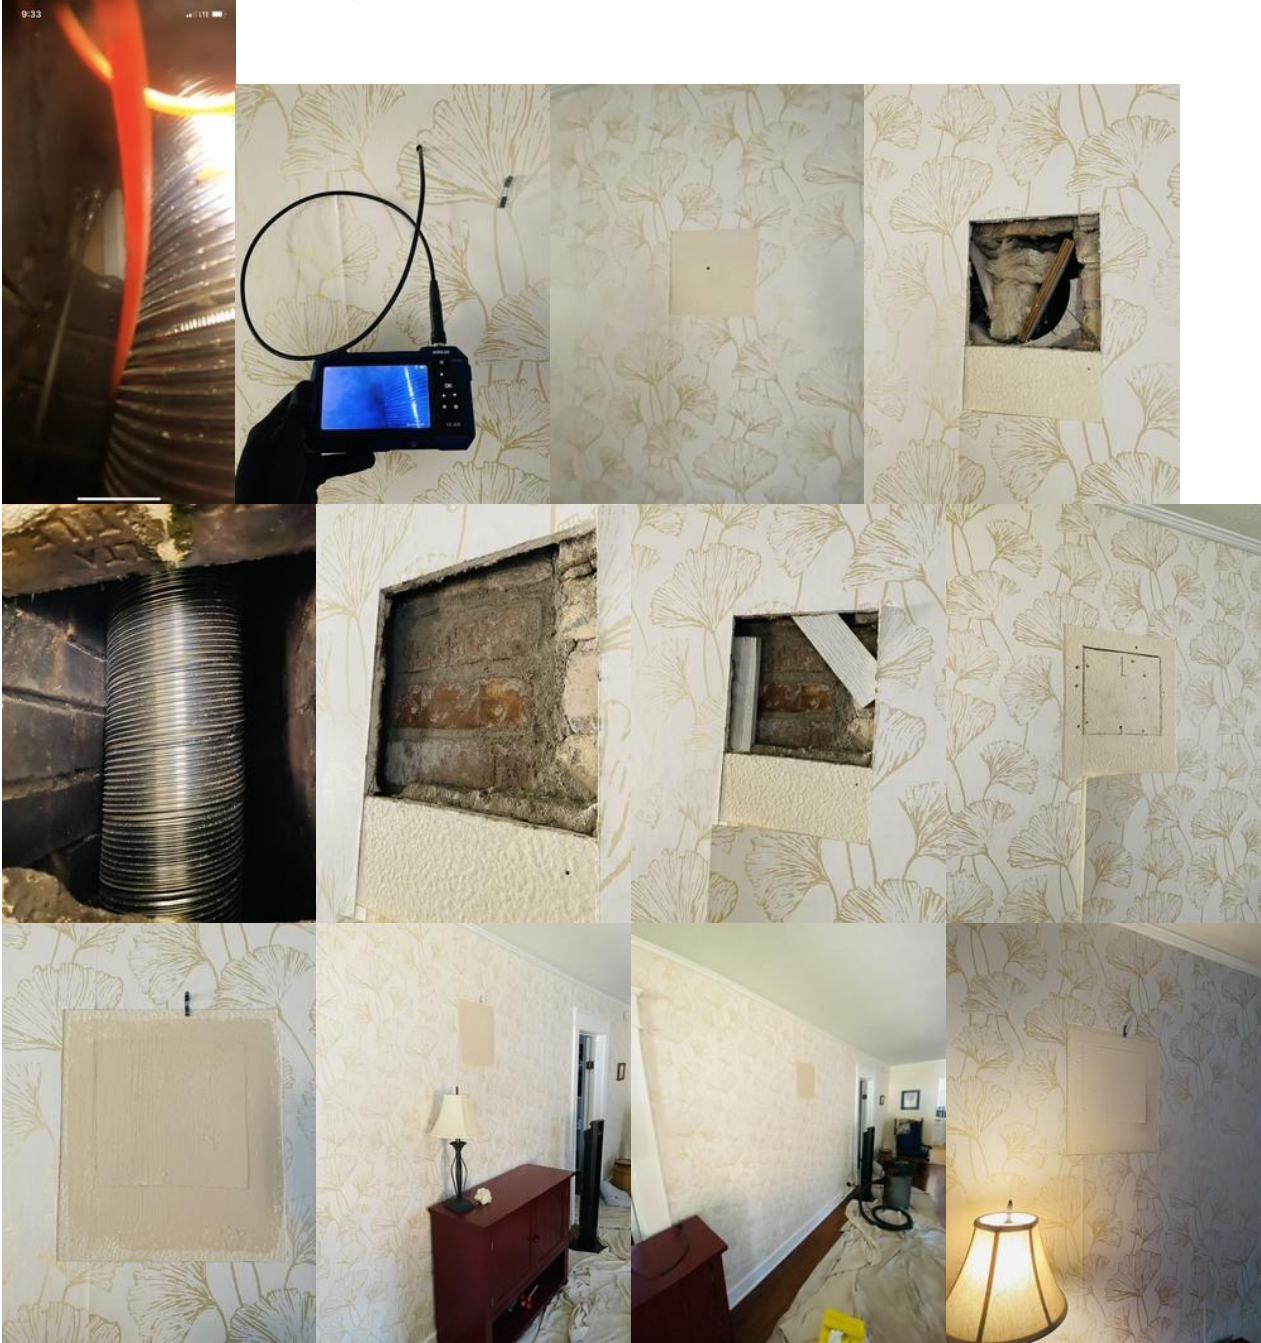
## Photo Documentation Group #1

Location of the unsealed thimble. Sealing of the thimble. Replacement of the sheetrock, mudding... customer said they are planning on doing a smear texture down the road. For now the picture will hang back up and cover the spot on the wall. The base of it pulled out a little from the wall as it dried (not visible in the photo).

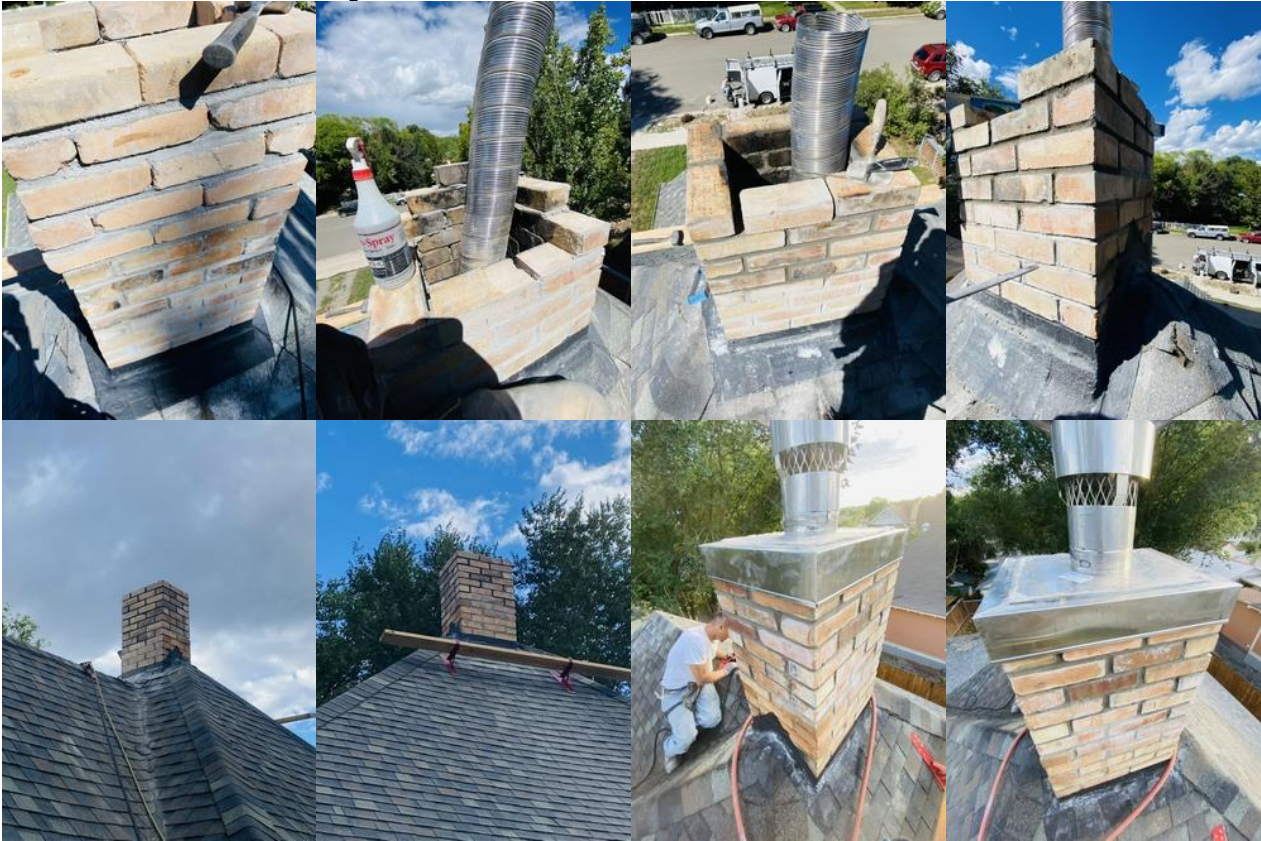
**Photo Documentation Group #2**

Chimney taken down and rebuilt where it was not square. Cap and chase cover reinstalled.

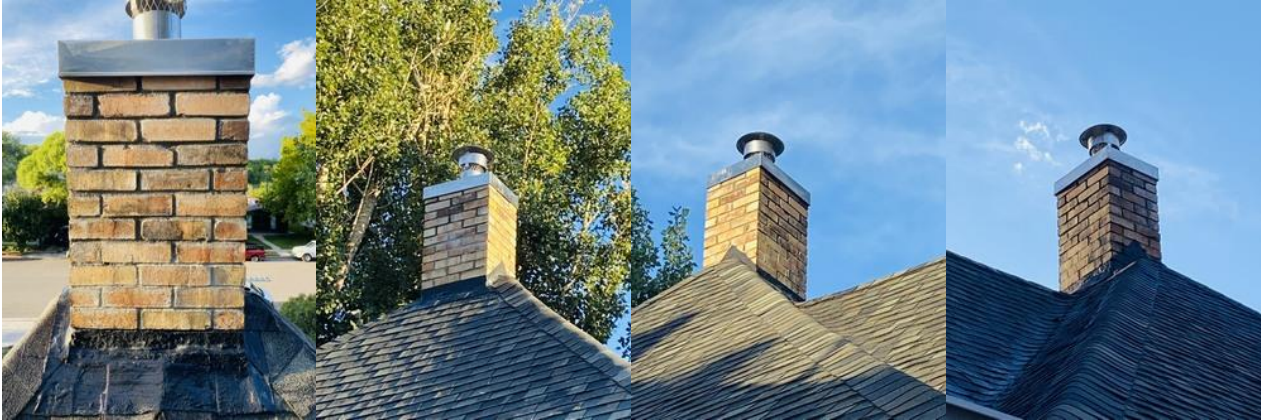
**Photo Documentation Group #3**

Completed chimney rebuild as visible from the ground up.

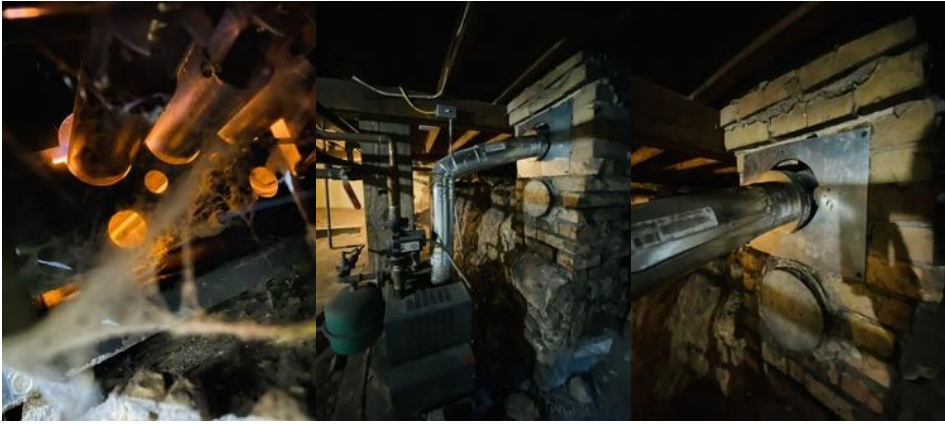
**Photo Documentation Group #5**

Furnace test fire and venting upon completion. CO test showed 000ppm.
