**The Chimney Doctor** | 970-234-3330  
2944 I-70 Business Loop #210, Grand Junction, CO 81501  
info@chimney.doctor | <https://chimney.doctor/>

## SERVICE / INSPECTION REPORT

Address, Edwards, Colorado 81632

12/05/2025

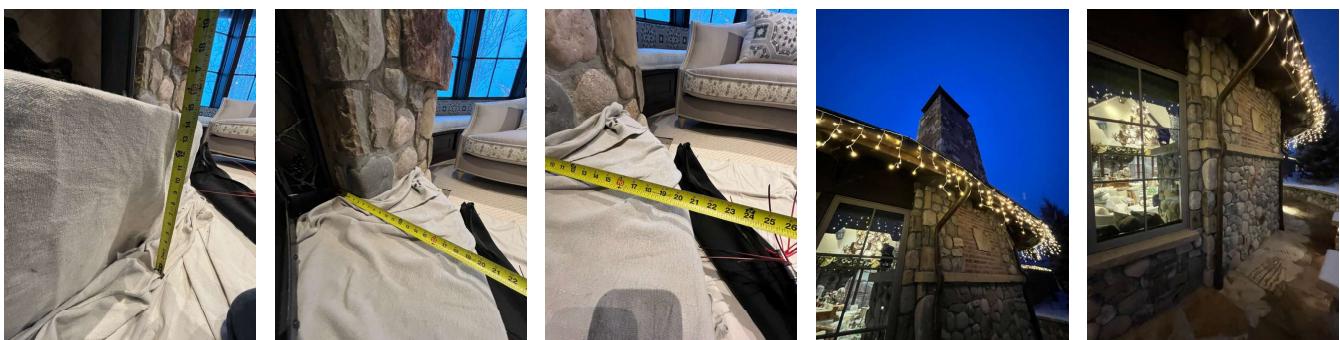
## Fireplace in the Pool House Living Room - HEARTH EXTENSION

As this is a mostly exterior structure with a basement below, the hearth extension is not fully supported by masonry and must have combustible flooring materials beneath.

#### **Hearth Extension: Improper construction, Combustibles beneath masonry hearth extension**

**Explanation:** Deficiencies related to the surround, facing materials, and fireplace dimensions were noted as outlined above. The front of a fireplace can reach extremely high temperatures during operation, requiring specific clearances to prevent overheating of combustible materials. Codes, NFPA 211, and manufacturer specifications for listed fireplaces dictate required distances between the fireplace opening and nearby materials. Some factory-built fireplaces also restrict the projection of non-combustible materials or require non-combustible framing behind them. Improper clearances, gaps, cracks, or insufficient support can lead to heat transfer issues, structural instability, and potential fire hazards. Dimensions not explicitly stated in manufacturer manuals cannot be assumed.

**Technician Recommendations:** It is recommended that the system NOT be used and is either repaired or replaced. Inserts and gas logs sets both rely on the original masonry system to meet minimum safety standards, which are not met, and should not be used.

A viable repair option may include a Retro-Fit Masonry Fireplace with a stainless steel liner, which would negate clearance requirements.

Replacement options include a Modular Masonry System and a Factory-Built Fireplace. Each of these systems have their own testing and listing requirements which would negate the present clearance issues within the existing system. Depending on the desired replacement option, invasiveness will vary.

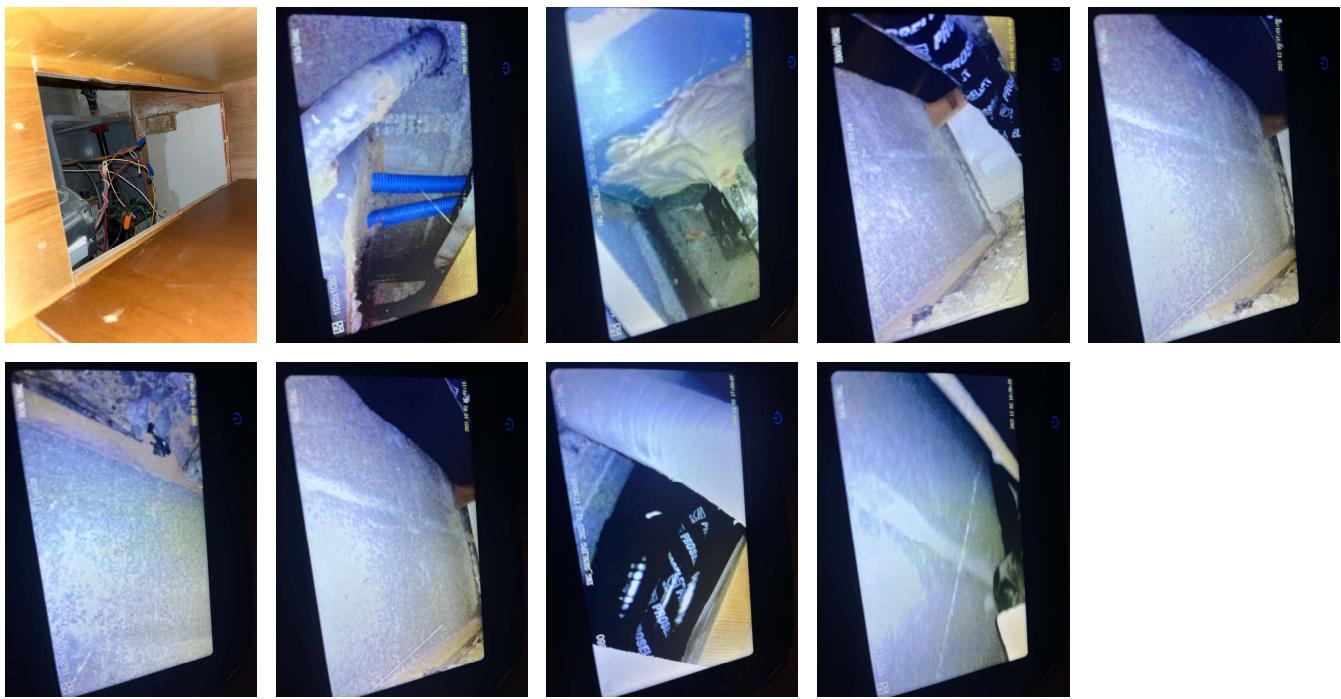
## Fireplace in the Pool House Living Room - FIREPLACE/APPLIANCE CONCEALED IN CONSTRUCTION

**Masonry Fireplace/SFU Concealed in Construction:** Clearances NOT met

Deficiencies related to a masonry fireplace or steel fireplace unit concealed in construction were noted as outlined above. Proper masonry construction and clearances prevent excessive heat transfer, which could weaken materials or ignite hidden combustibles. Exposed hollow block cores, insufficient masonry thickness, or combustibles beneath the hearth pose serious fire risks. Over time, prolonged heat exposure can deteriorate surrounding materials, leading to structural or safety concerns. Hidden combustible materials may char or ignite under extreme conditions. These fireplaces must be inspected to verify compliance with code and construction standards to ensure safe operation and long-term durability.

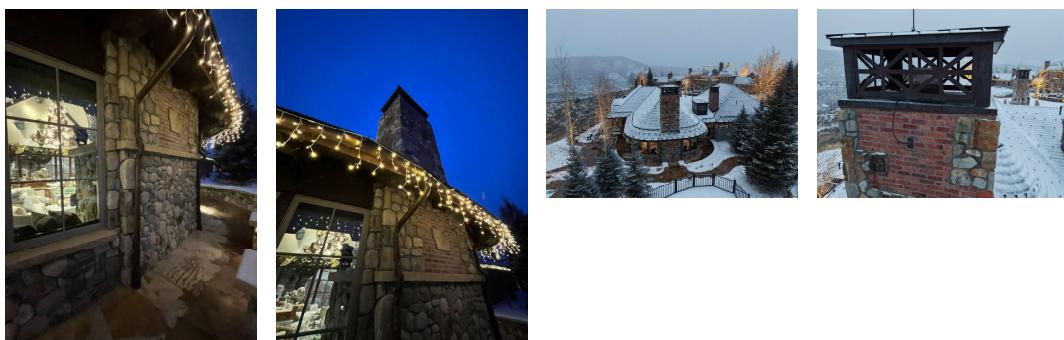
## Fireplace in the Pool House Living Room - CHASE OR MASONRY STRUCTURE EXTERIOR

**Chase or Masonry Structure Exterior:** Other Issue

**Explanation:** Deficiencies related to the exterior of the masonry chimney or framed chase were noted as outlined above. The exterior serves as the first line of defense against structural damage and moisture intrusion. MASONRY chimneys must be inspected for cracked, spalling, or missing bricks or stones, deteriorated mortar joints, efflorescence, organic growth, or visible moisture penetration. FRAMED CHASES should be checked for water damage, siding deterioration, and improper construction that could allow moisture infiltration. Left unaddressed, these issues can lead to internal damage, reduced structural integrity, and costly repairs over time.

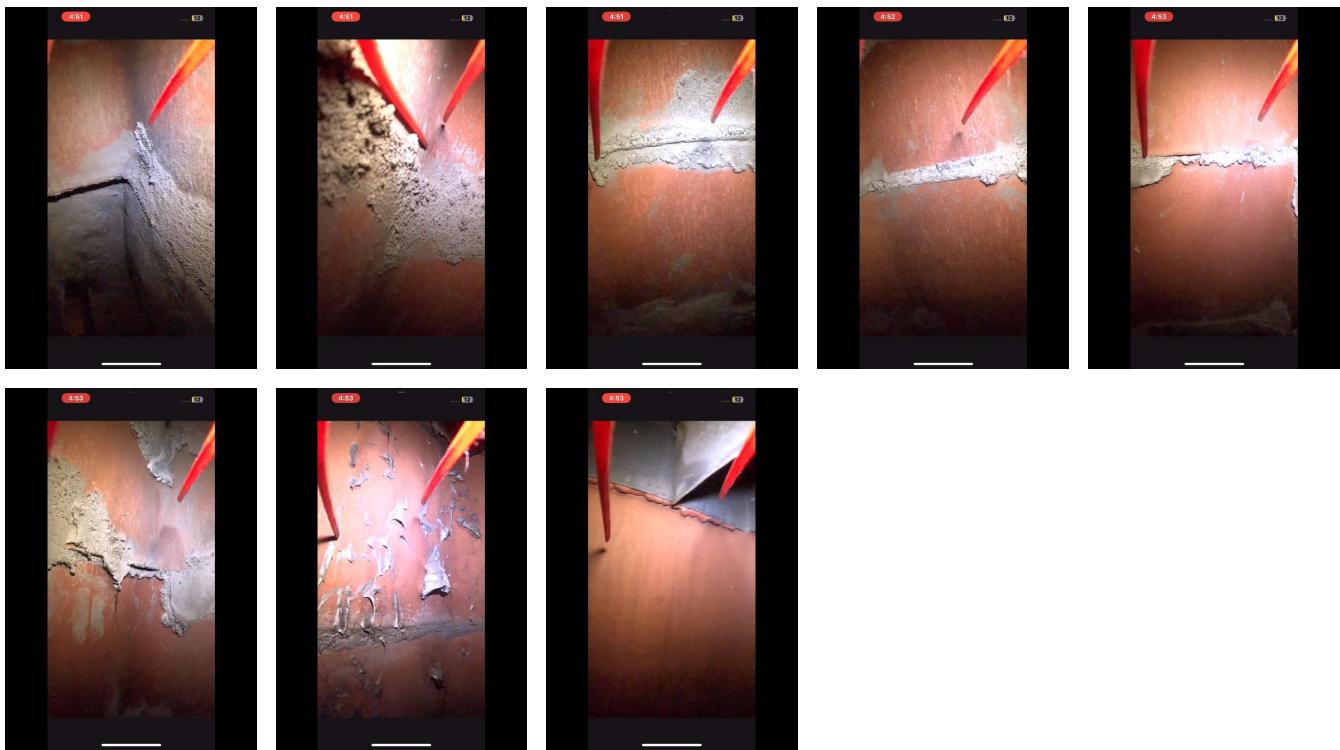
## Fireplace in the Pool House Living Room - CHIMNEY, VENT, OR FLUE INTERIOR

### Masonry Chimney/Flue Interior: Excess mortar at liner joints, Other Issue

**Explanation:** Deficiencies related to the masonry flue interior were noted as outlined above. Internal inspections are essential to assess flue integrity and identify hazards such as excessive creosote buildup, deterioration, gaps, or obstructions. Masonry flues should be inspected for broken tiles, mortar gaps, or soot migration outside the liner. A compromised flue interior can lead to drafting issues, increased fire risk, or carbon monoxide exposure, making regular inspections critical.

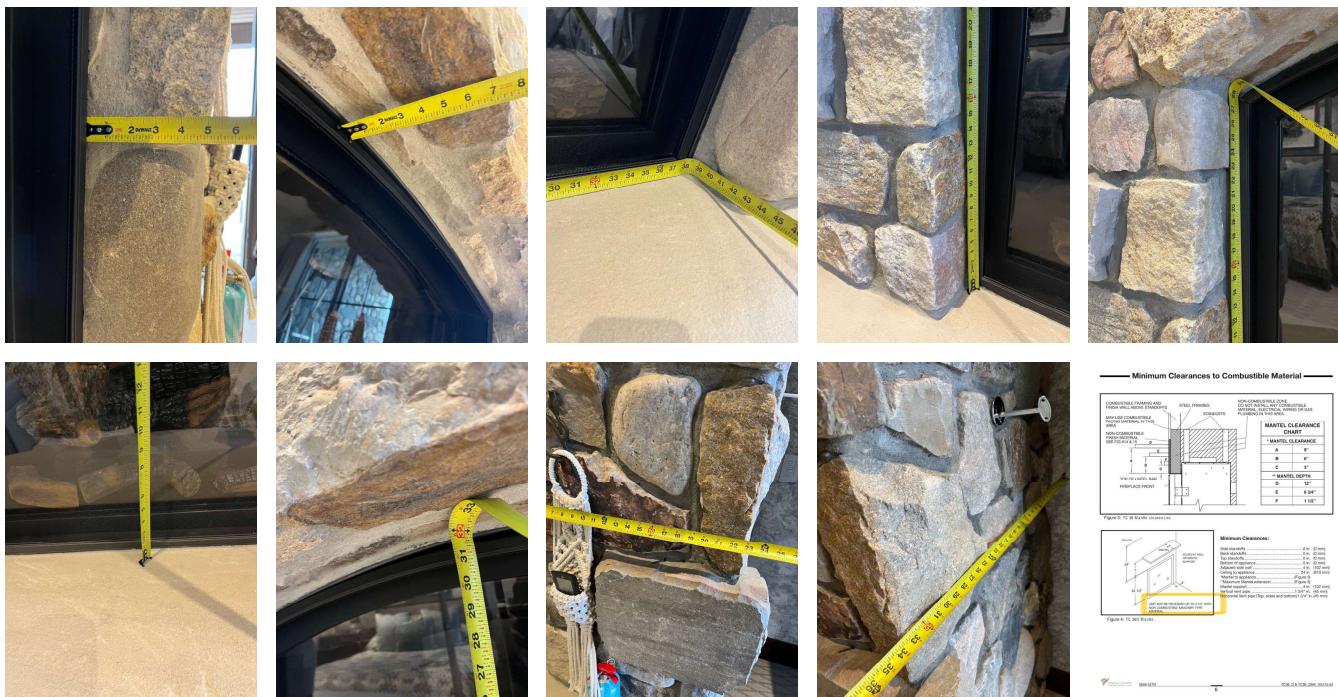
## Fireplace in the Pool House Grey Room - SURROUND, FACING MATERIALS, AND DIMENSIONS

### Surround, Facing Materials, and Dimensions: Other Issue

**Explain other issue(s):** Unit is recessed inside of noncombustible material further than allowed by the manufacturer.

**Explanation:** Deficiencies related to the surround, facing materials, and fireplace dimensions were noted as outlined above. The front of a fireplace can reach extremely high temperatures during operation, requiring specific clearances to prevent overheating of combustible materials. Codes, NFPA 211, and manufacturer specifications for listed fireplaces dictate required distances between the fireplace opening and nearby materials. Some factory-built fireplaces also restrict the projection of non-combustible materials or require non-combustible framing behind them. Improper clearances, gaps, cracks, or insufficient support can lead to heat transfer issues, structural instability, and potential fire hazards. Dimensions not explicitly stated in manufacturer manuals cannot be assumed.

**Technician Recommendations:** It is recommended that the system NOT be used until proper repairs are made. This would include reconstructing the facing material to meet the manufacturer's recessed depth requirement, securing/ removing the insulation from the chase cavity and replacing the damaged section of venting as well as any venting damaged in accessing it.

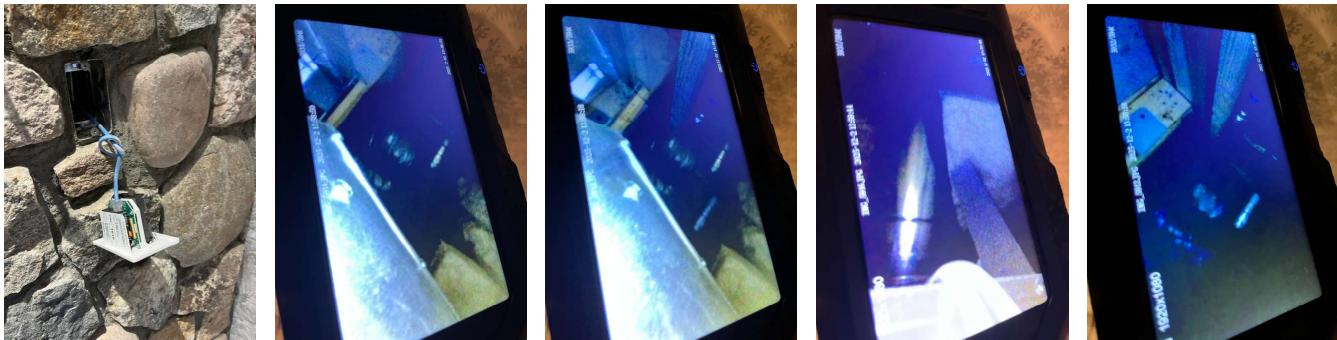
## Fireplace in the Pool House Grey Room - FIREPLACE/APPLIANCE CONCEALED IN CONSTRUCTION

**Factory-Built System Concealed in Construction:** Clearances NOT met

**Explanation:** Deficiencies related to a factory-built system concealed in construction were noted as outlined above. Factory-built fireplaces and certain hearth/heating appliances are designed to be installed behind finished walls or inside chases with specific clearance requirements. Manufacturer instructions dictate the necessary air space between the appliance and surrounding combustible materials, including framing, insulation, and sheathing. Failure to meet required clearances can result in excessive heat transfer, degradation of surrounding materials, or ignition of combustibles. Additional concerns include improper gas line or air intake clearances, moisture or animal entry, and missing protective components such as ember strips or Z-strips, all of which can compromise safety and performance.

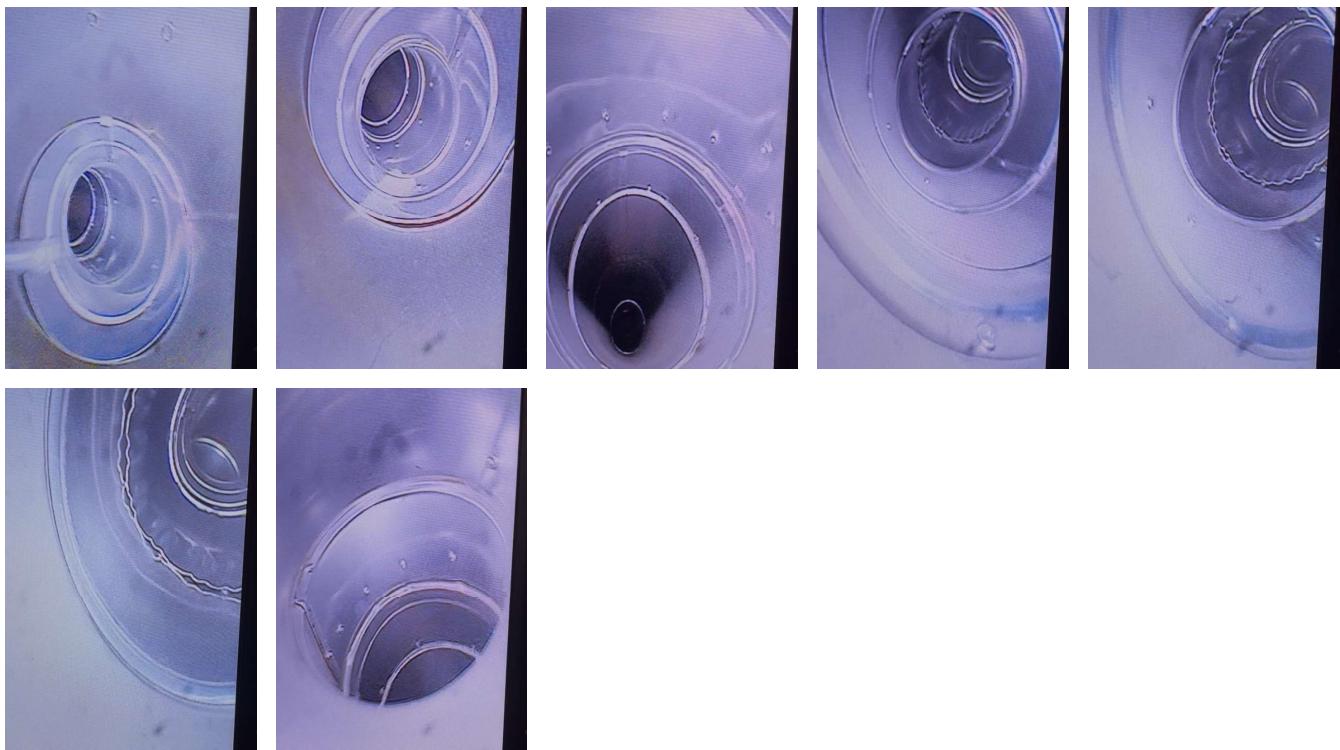
## Fireplace in the Pool House Grey Room - CHIMNEY, VENT, OR FLUE INTERIOR

### Factory-Built Chimney, Vent, or Flue Interior: Other Issue

**Explanation:** Deficiencies related to the factory-built flue interior were noted as outlined above. Internal inspections are essential to assess flue integrity and identify hazards such as excessive creosote buildup, deterioration, gaps, or obstructions. Factory-built chimneys and relined systems must be checked for rust, buckling, and seam failures. A compromised flue interior can lead to drafting issues, increased fire risk, or carbon monoxide exposure, making regular inspections critical.

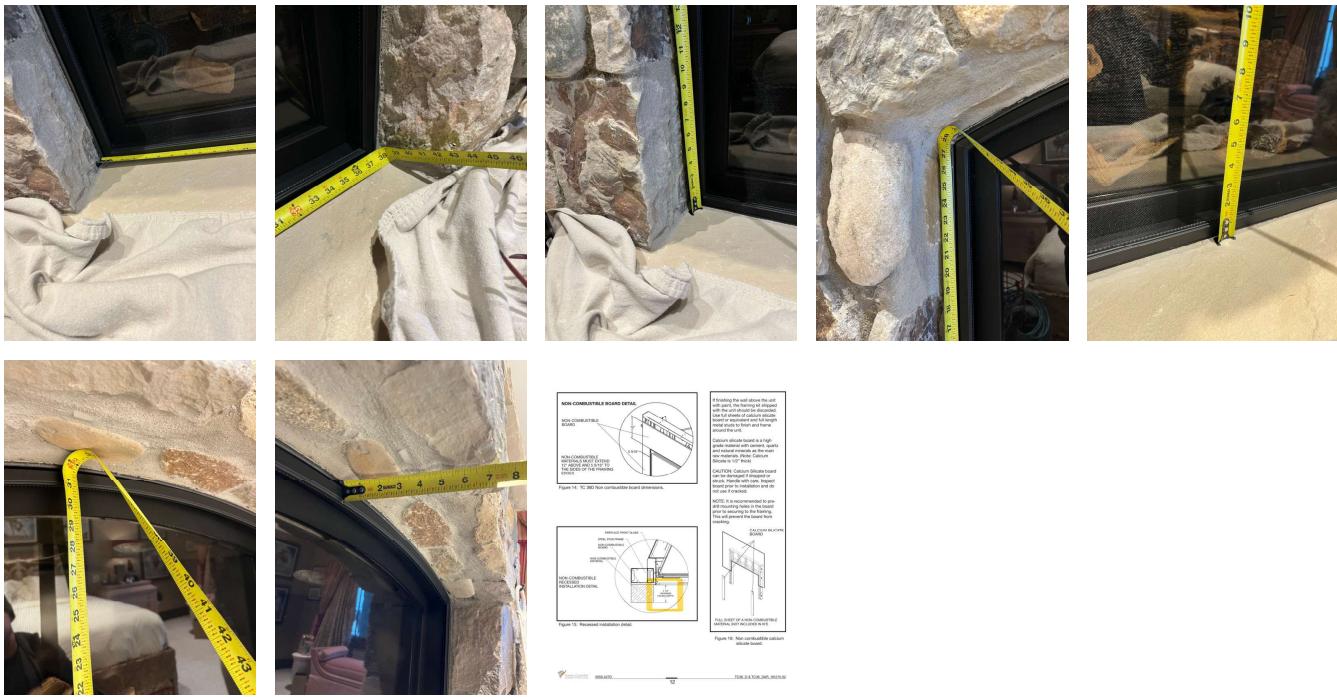
## Fireplace in the Pool House Pink Room - SURROUND, FACING MATERIALS, AND DIMENSIONS

### Surround, Facing Materials, and Dimensions: Other Issue

**Explain other issue(s):** Appliance is recessed further than allowed but the manufacturer.

**Explanation:** Deficiencies related to the surround, facing materials, and fireplace dimensions were noted as outlined above. The front of a fireplace can reach extremely high temperatures during operation, requiring specific clearances to prevent overheating of combustible materials. Codes, NFPA 211, and manufacturer specifications for listed fireplaces dictate required distances between the fireplace opening and nearby materials. Some factory-built fireplaces also restrict the projection of non-combustible materials or require non-combustible framing behind them. Improper clearances, gaps, cracks, or insufficient support can lead to heat transfer issues, structural instability, and potential fire hazards. Dimensions not explicitly stated in manufacturer manuals cannot be assumed.

**Technician Recommendations:** It is recommended that the system NOT be used until proper repairs are made. This would include reconstructing the facing material to meet the manufacturer's recessed depth requirement and replacing the damaged venting as well as any venting damaged in accessing it.

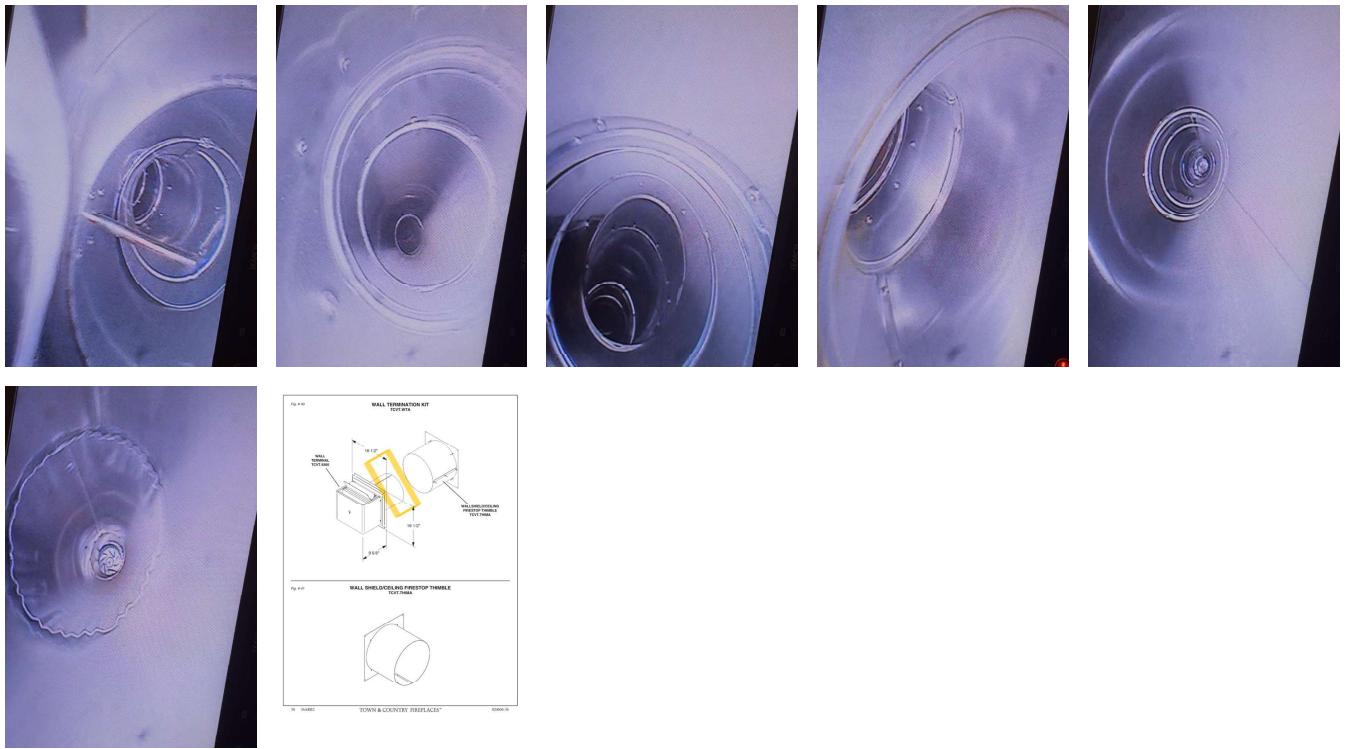
## Fireplace in the Pool House Pink Room - CHIMNEY, VENT, OR FLUE INTERIOR

**Factory-Built Chimney, Vent, or Flue Interior:** Other Issue

**Explanation:** Deficiencies related to the factory-built flue interior were noted as outlined above. Internal inspections are essential to assess flue integrity and identify hazards such as excessive creosote buildup, deterioration, gaps, or obstructions. Factory-built chimneys and relined systems must be checked for rust, buckling, and seam failures. A compromised flue interior can lead to drafting issues, increased fire risk, or carbon monoxide exposure, making regular inspections critical.
