SERVICE / INSPECTION REPORT

Address, Aspen, CO 81611

Kitchen Wood Stove

Type of Inspection: Level II Inspection (Accessible Areas)

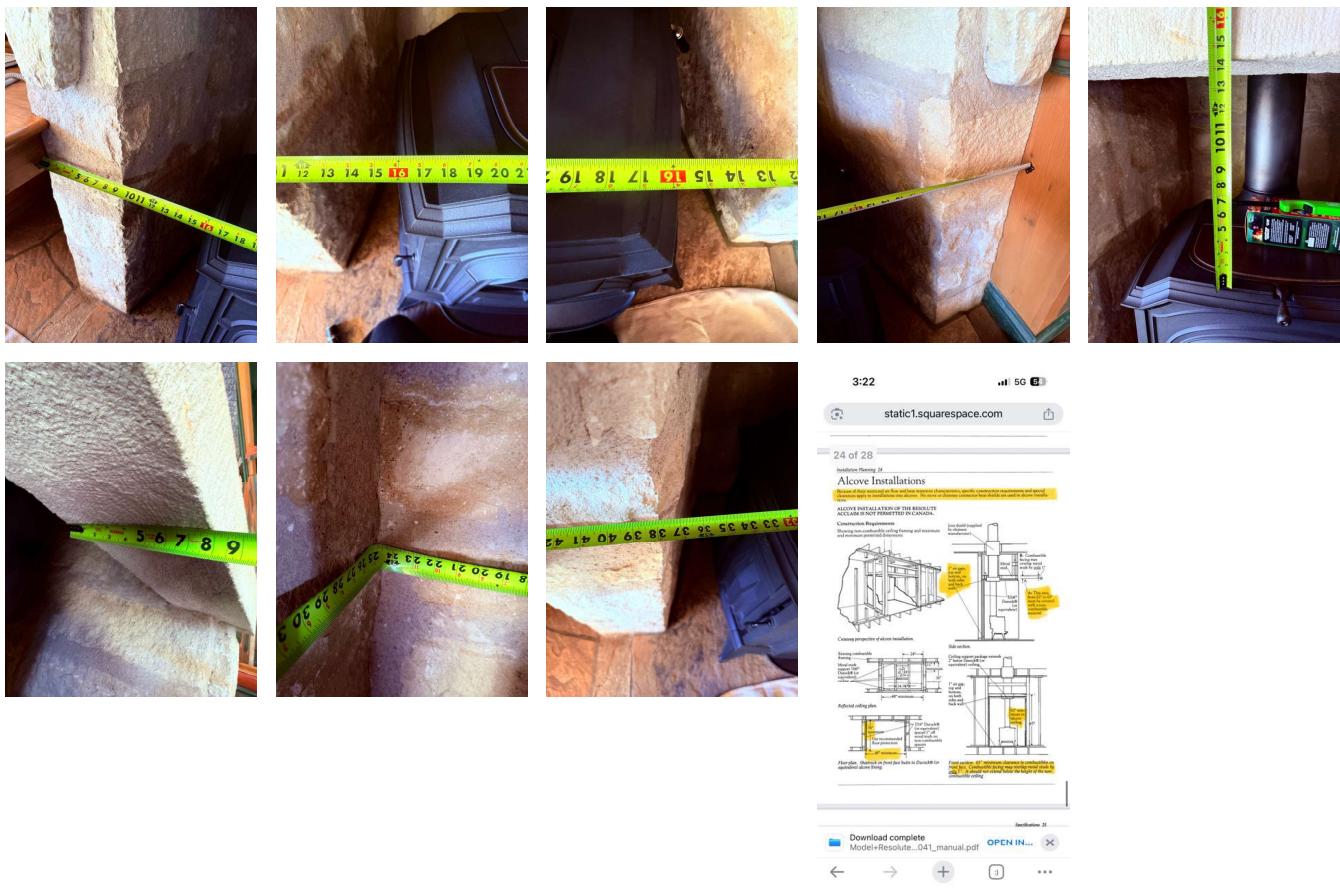
Kitchen Wood Stove - APPLIANCE CONDITION/CLEARANCES

Clearances to wood on the sides are met however Alcove construction and sizing requirements per the manual were not met.

Appliance Condition/Clearances: Alcove improperly sized/constructed

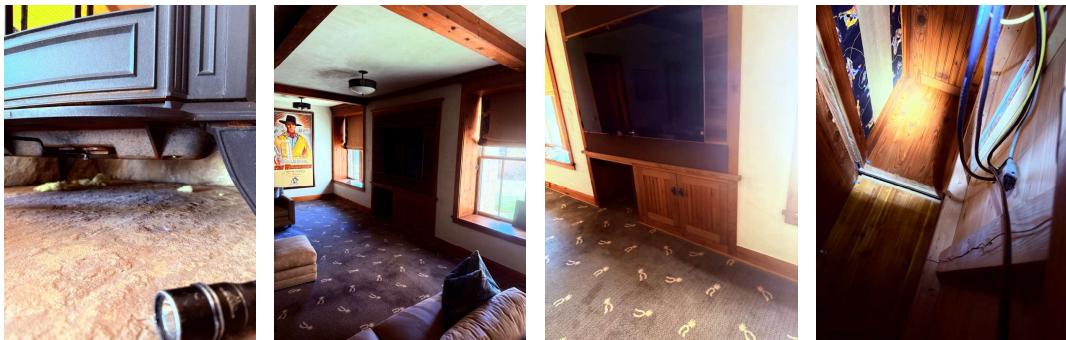
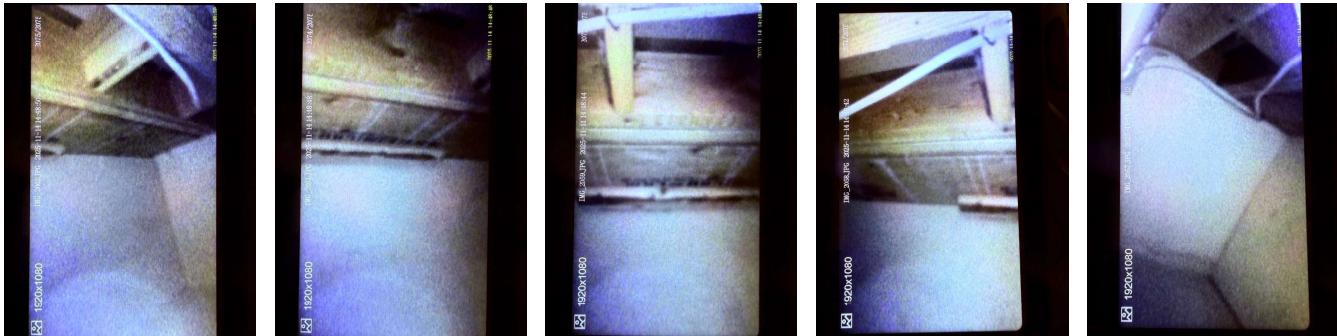
Kitchen Wood Stove - APPLIANCE FLOOR OR WALL PROTECTION

Appliance Floor or Wall Protection: Insufficient R-value, Other Issue

Explain other issue(s): Required bottom heat shield is missing. Combustible wood framing was noted during inspection of the flooring area beneath the stove through the cabinet for the TV below.

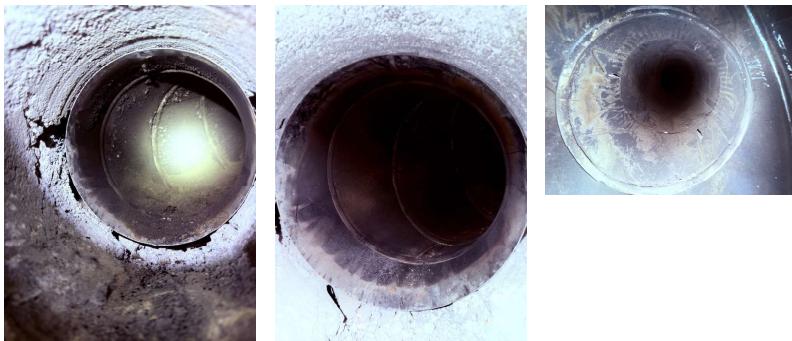
Kitchen Wood Stove - CONNECTION TO CHIMNEY, VENT, FLUE, OR LINER

Connection to Factory-Built Chimney/Vent: Other Issue

Connection to Masonry Chimney/Flue: Other Issue

Explain other issue(s): Piping is galvanized on the other side of the penetration into the masonry chase structure. The masonry structure does not meet minimum thickness requirements as a masonry chimney and galvanized piping was used in an inaccessible location.

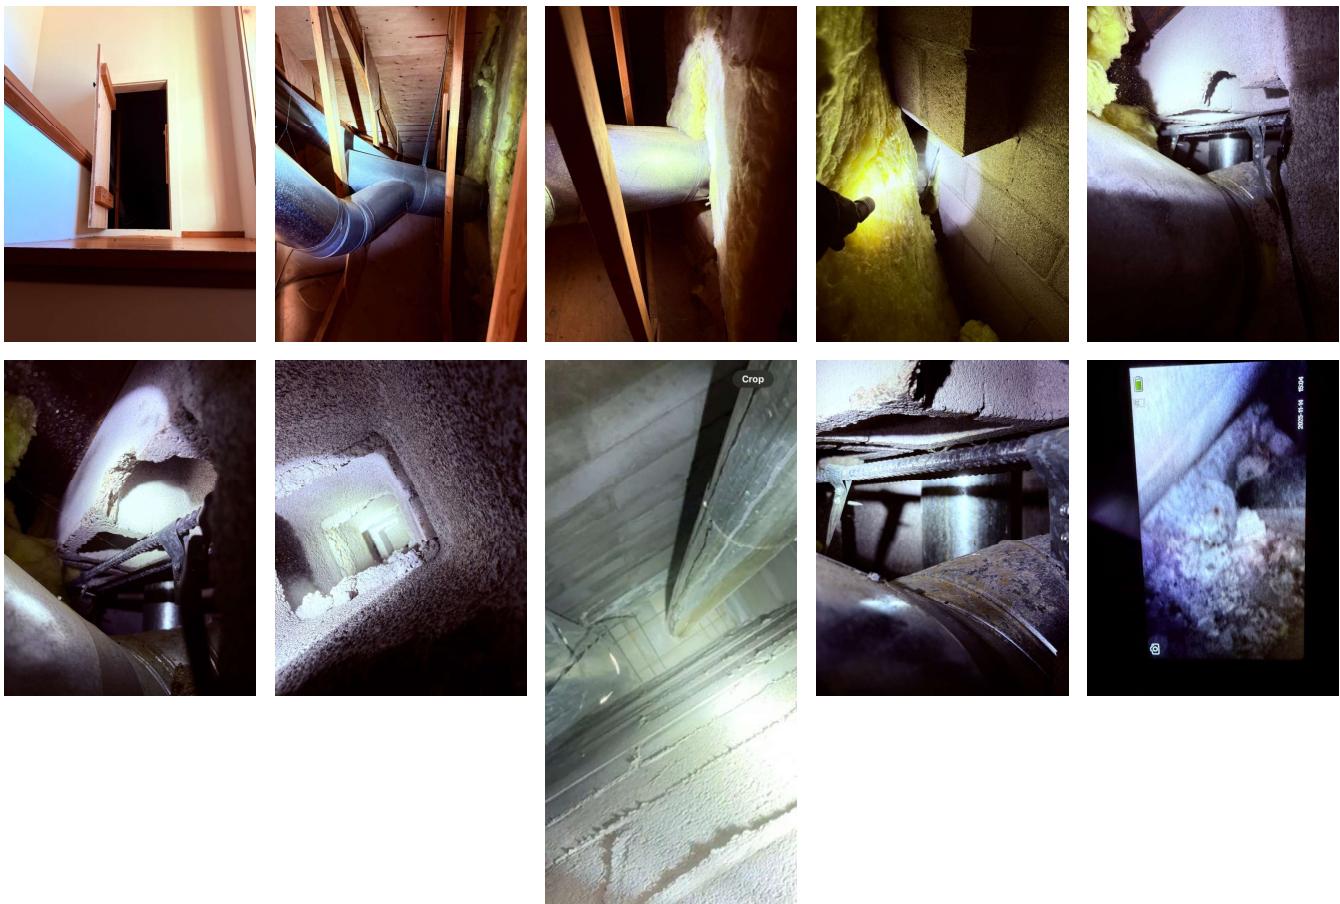
Kitchen Wood Stove - CHIMNEYS/VENTS IN ADJOINING AREAS

Factory-Built Chimney/Vent in Adjoining Areas: Evidence of water entry, Rusted/corroded, Improperly installed/sized, Piping exposed in living/storage space not enclosed, Other Issue

Masonry Chimney/Structure in Adjoining Areas: Clearances NOT met, Gaps/cracks, Exposed/hollow block cores

Explain other issue(s): Piping is galvanized inside a masonry hollow block chase that was not completed nor filled solid to meet minimum thickness requirements. Were the block all solid clearances are not met at the ceiling/roof/floor penetrations.

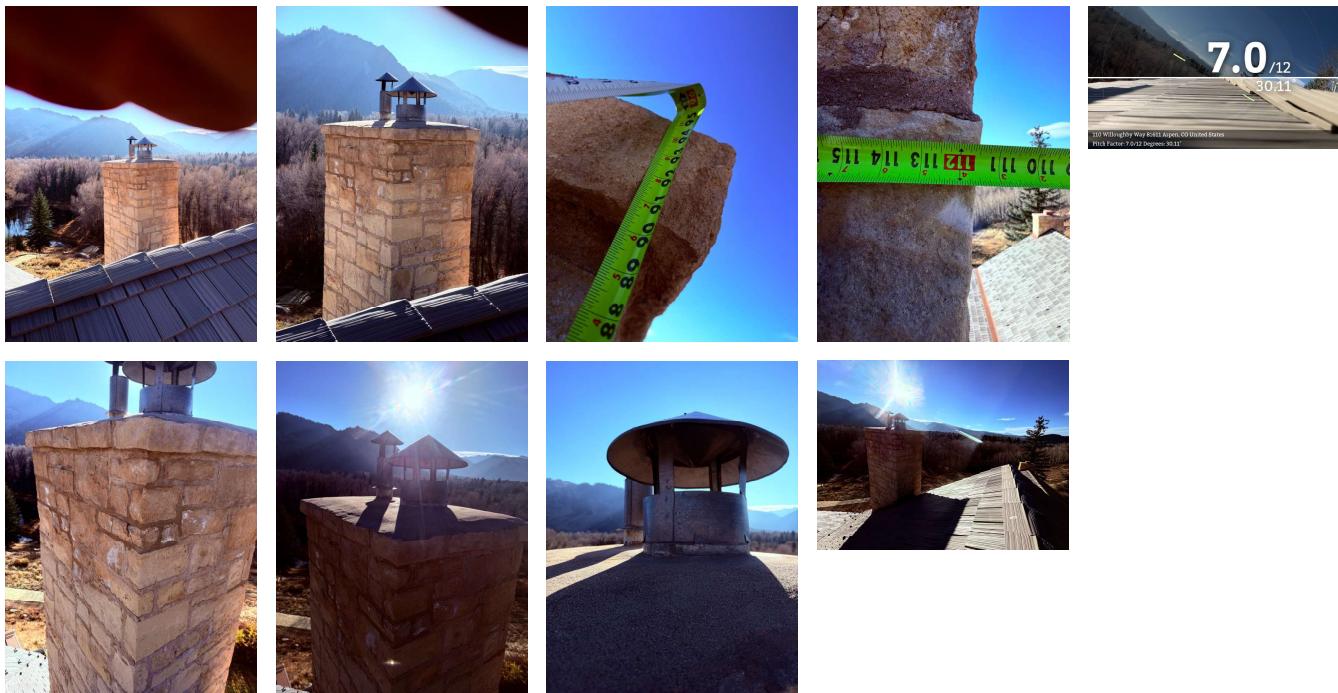
Kitchen Wood Stove - TERMINATION

Masonry Termination: Cap rusted/deteriorated/damaged

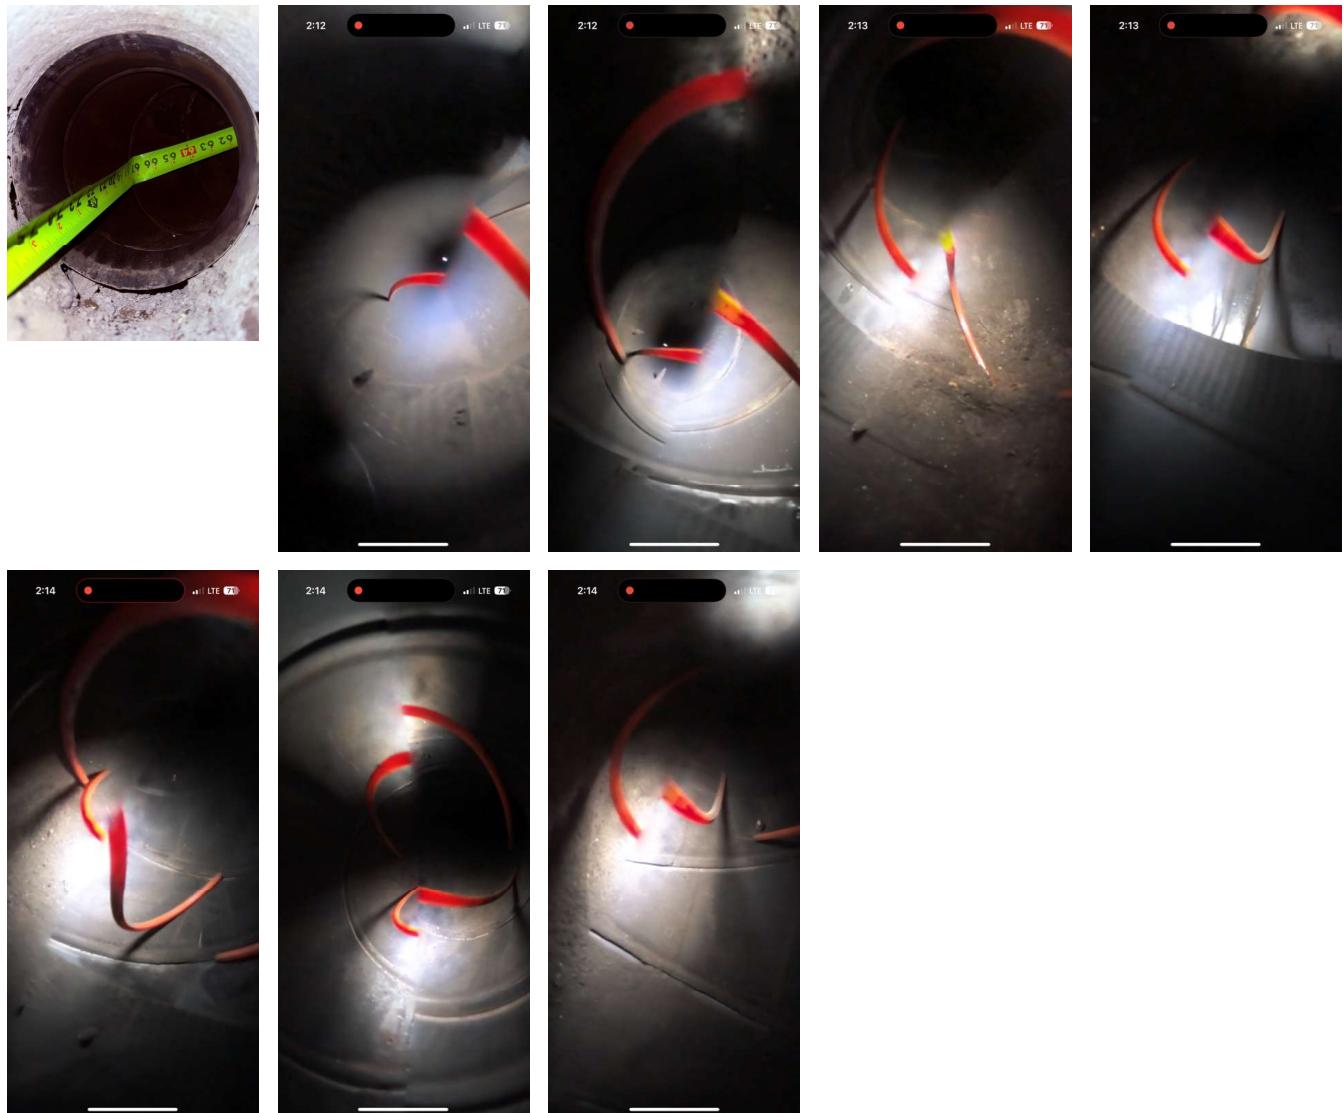
Internal Camera Inspection -

Multiple elbows were noted in the horizontal. 6' horizontal was measured. System was swept to the top. Internal camera inspection could not fully reach the top due to the elbows at the far end however galvanized piping used as a chimney was visible through the attic access.
