**The Chimney Doctor Ltd.** | 970-234-3330  
2944 I-70 Business Loop #210, Grand Junction, CO 81501  
info@chimney.doctor | <https://chimney.doctor>

## SERVICE / INSPECTION REPORT

Address, Cedaredge, CO 81413

## Living Room Wood Stove

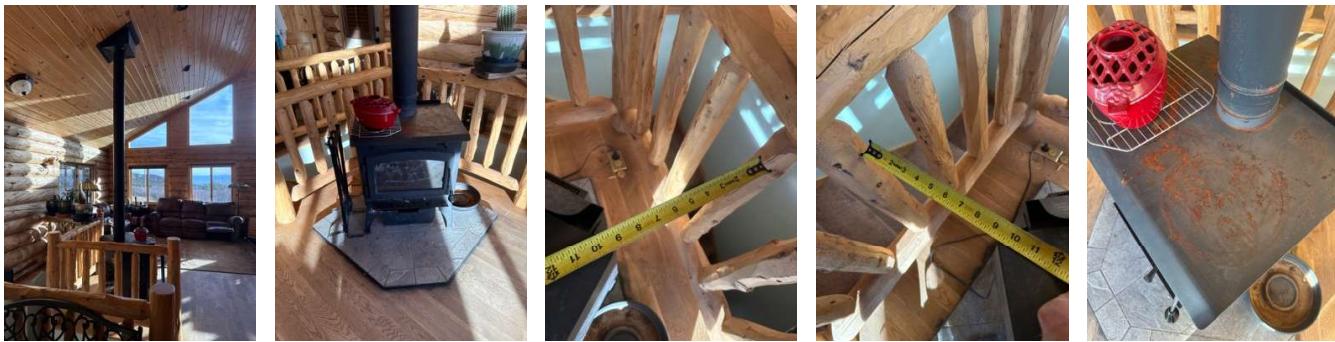
## Living Room Wood Stove - APPLIANCE CONDITION/CLEARANCES

**Appliance Condition/Clearances:** Rusted/corroded, Appliance clearances NOT met

**Explanation:** Deficiencies related to the appliance condition and clearances were noted as outlined above. Appliances must be installed in accordance with manufacturer specifications and code requirements, ensuring proper clearances to combustibles. Warping, rust, corrosion, or evidence of water entry can compromise the appliance's structural integrity and safe operation. Modifications, alterations, or improper installations may lead to overheating, venting malfunctions, or fire hazards. If located in an unapproved area or within an improperly sized alcove poses a potential fire hazard and safety risk. Any failure to meet minimum clearance requirements increases the risk of fire and appliance failure.

**Technician Recommendations:** It is recommended that the floor protection and chimney system are replaced prior to use. The flashing is temporarily sealed with silicone but will break loose as soon as weight is applied.

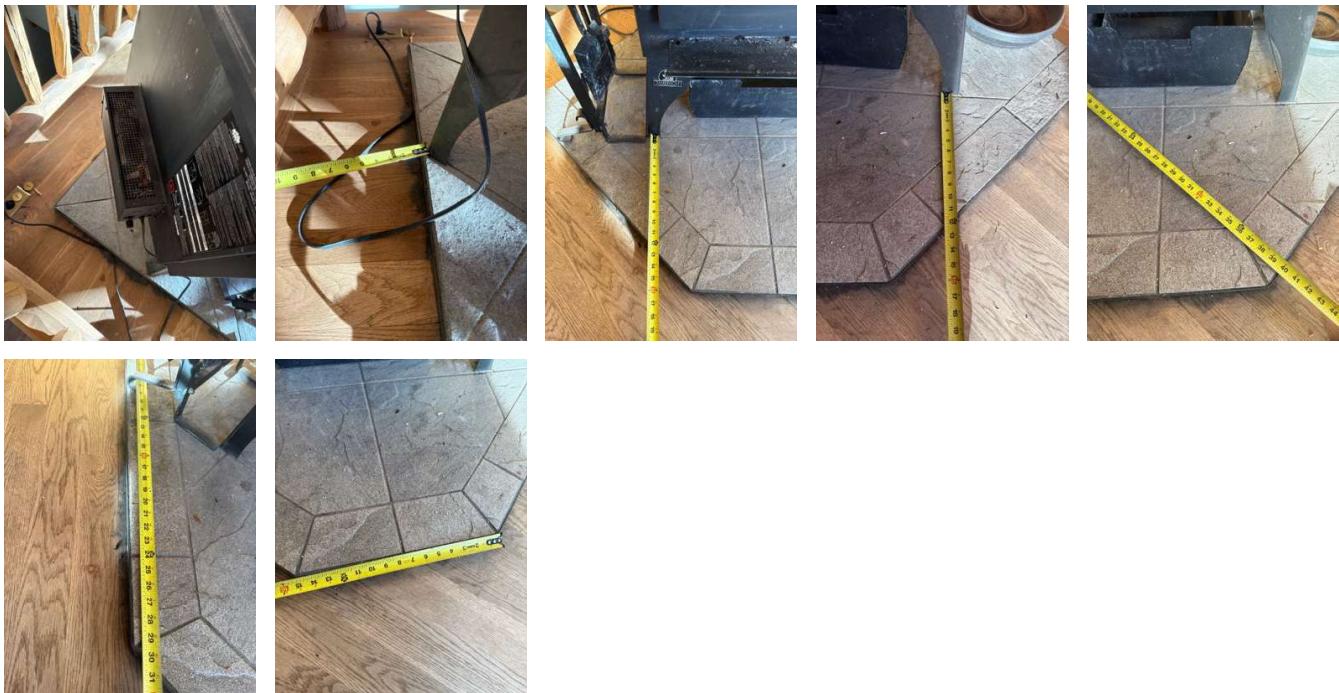
#### Living Room Wood Stove - APPLIANCE FLOOR OR WALL PROTECTION

#### Appliance Floor or Wall Protection: Insufficient size

**Explanation:** Deficiencies related to appliance floor or wall protection were noted as outlined above. Floor protection is required beneath certain hearth and heating appliances and must meet either the manufacturer's listed requirements or applicable codes and standards for unlisted appliances. It serves to prevent heat transfer to combustible materials and protect against stray embers or sparks. Insufficient size, improper materials, or inadequate thermal resistance (R-value) may compromise safety, increasing the risk of fire. If wall protection or clearance reduction systems are used, they must be properly constructed and installed. Any noted deficiencies may indicate that the floor or wall protection is inadequate for safe operation.

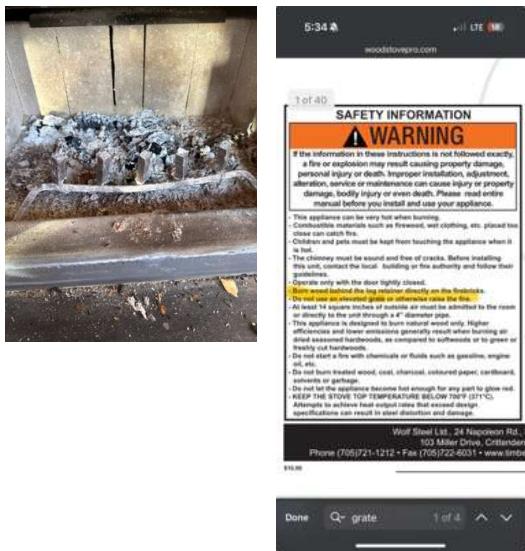
### Living Room Wood Stove - GRATES, BURNERS, AND MEDIA

**Grates, Burners, and Media:** Aftermarket

**Explanation:** Deficiencies related to the grate, burner, or media were noted as outlined above. These components support combustion and ensure proper airflow, flame presentation, and media placement in gas or propane appliances. In masonry fireplaces and unlisted modular masonry fireplaces, grates can generally be used unless they contribute to firebox damage. However, listed factory-built fireplaces, modular masonry fireplaces, and hearth/heating appliances must use only grates, burners, or media tested and approved by the manufacturer. Using unapproved components may alter the heat signature of the appliance, create fire hazards, and affect efficiency. Any noted deficiencies may compromise appliance performance and safety, requiring further evaluation.

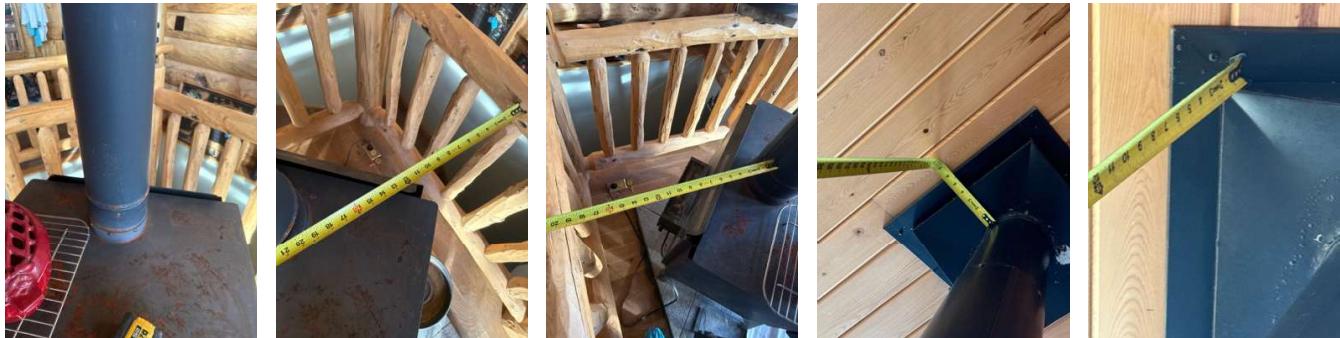
#### Living Room Wood Stove - CONNECTOR PIPING

**Connector Piping:** Clearances NOT met, Rusted/corroded

**Explanation:** Deficiencies related to the connector piping were noted. Connector piping directs exhaust gases from the appliance to the chimney or vent system and must be properly installed to prevent overheating, gas spillage, and inefficient operation. The type, size, material, and clearances must comply with manufacturer specifications and code requirements. Improper fasteners, inadequate support, excessive horizontal runs, or incorrect penetrations through walls or ceilings can compromise safety and performance. Any deviations from approved installation practices can increase fire risk, reduce draft effectiveness, or lead to system failure.

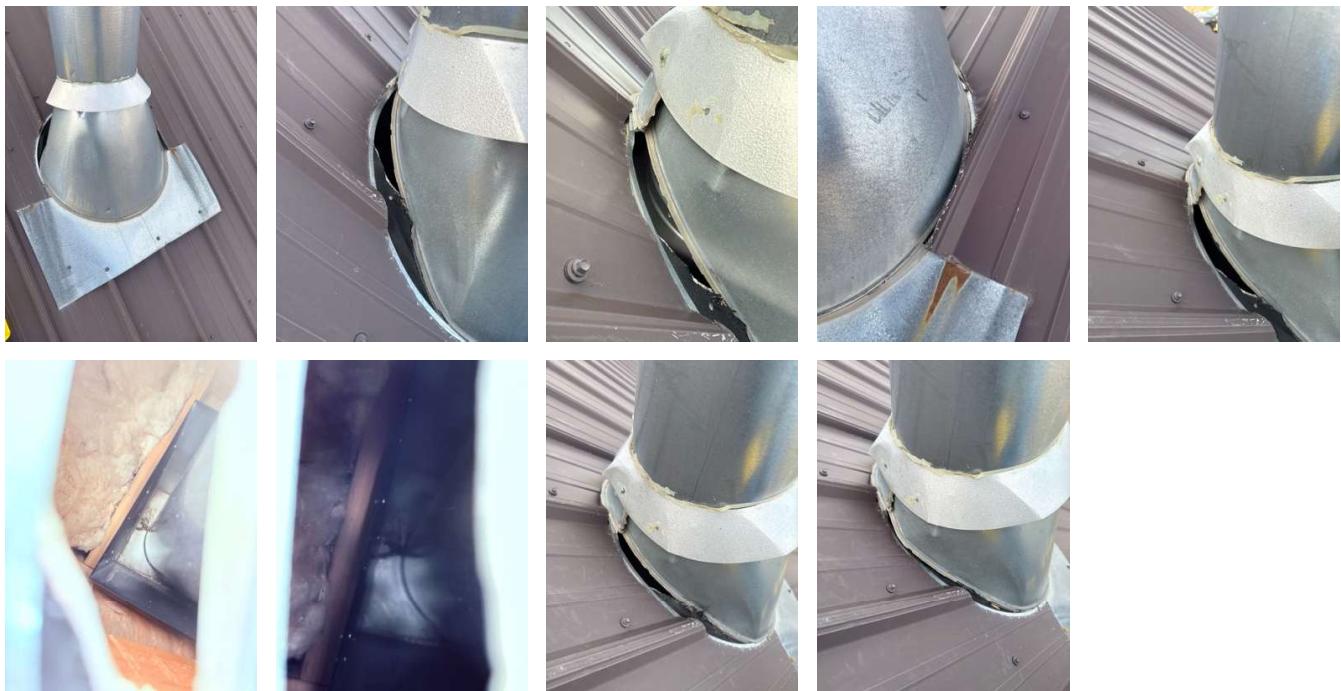
#### Living Room Wood Stove - FLASHINGS AND CRICKETS

**Flashings and Crickets:** Damaged/deteriorated, Separation/lifting

**Explanation:** Deficiencies related to the flashing and/or chimney cricket were noted as outlined above. Flashings create a watertight seal where the chimney or vent meets the roof, preventing leaks and structural damage. If improperly installed, missing, or deteriorated, water can penetrate the roof system, leading to wood rot, mold growth, and interior damage. A chimney cricket, required for wide chimneys, helps divert water and debris away from the structure. Without a properly installed cricket, excessive water runoff can deteriorate masonry, corrode flashing, and contribute to long-term moisture issues. Inspecting and maintaining these components ensures proper water management and structural integrity.

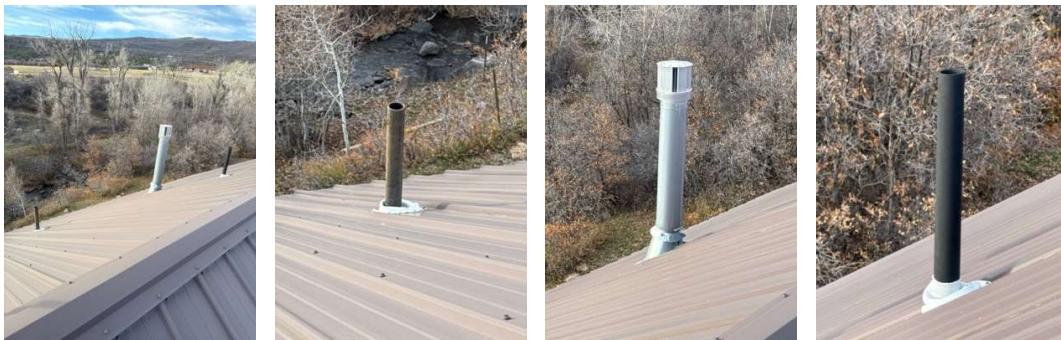
## Living Room Wood Stove - PERIPHERAL SYSTEMS DURING EXTERIOR INSPECTION

Vents on other side of the roof.

**Peripheral Systems During Exterior/Termination Inspection:** Nothing to report

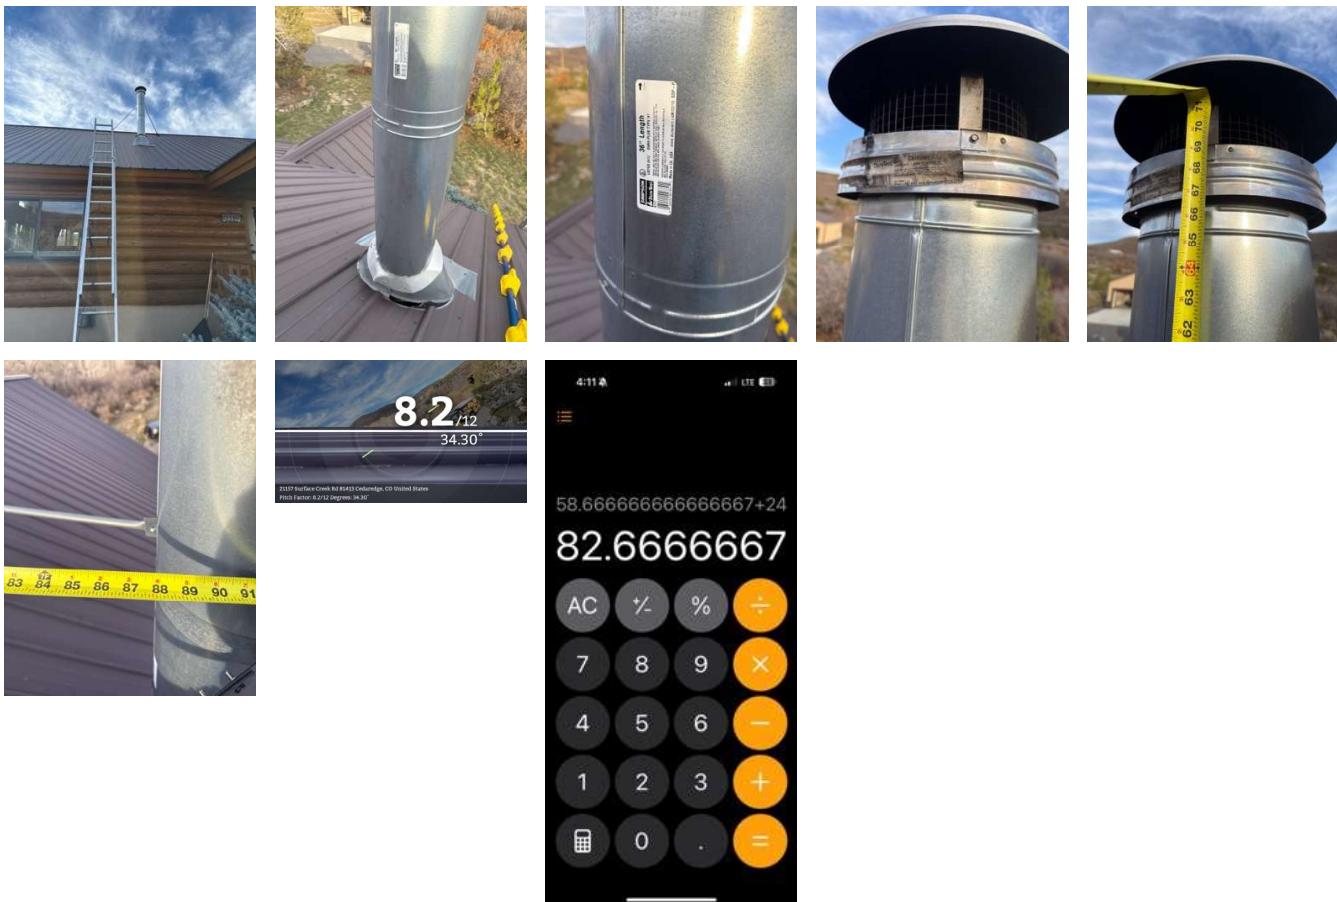
## Living Room Wood Stove - TERMINATION

**Factory-Built Termination:** Height requirements NOT met, Other Issue

**Explanation:** Deficiencies related to the factory-built chimney/vent termination were noted as outlined above. A proper chimney, vent, or flue termination prevents moisture intrusion, ensures adequate draft, and keeps debris or animals from obstructing the system. Factory-built chimneys/vents may terminate vertically or horizontally depending on the appliance installed and the venting used. Aftermarket, incorrect or missing terminations, rusted or damaged caps, or improper flue sizing can lead to draft failure, moisture damage, and increased fire risks. Air cooled systems that have been compromised can overheat construction elsewhere in the building envelope. A properly installed and maintained termination is critical to the longevity and safety of the venting system.

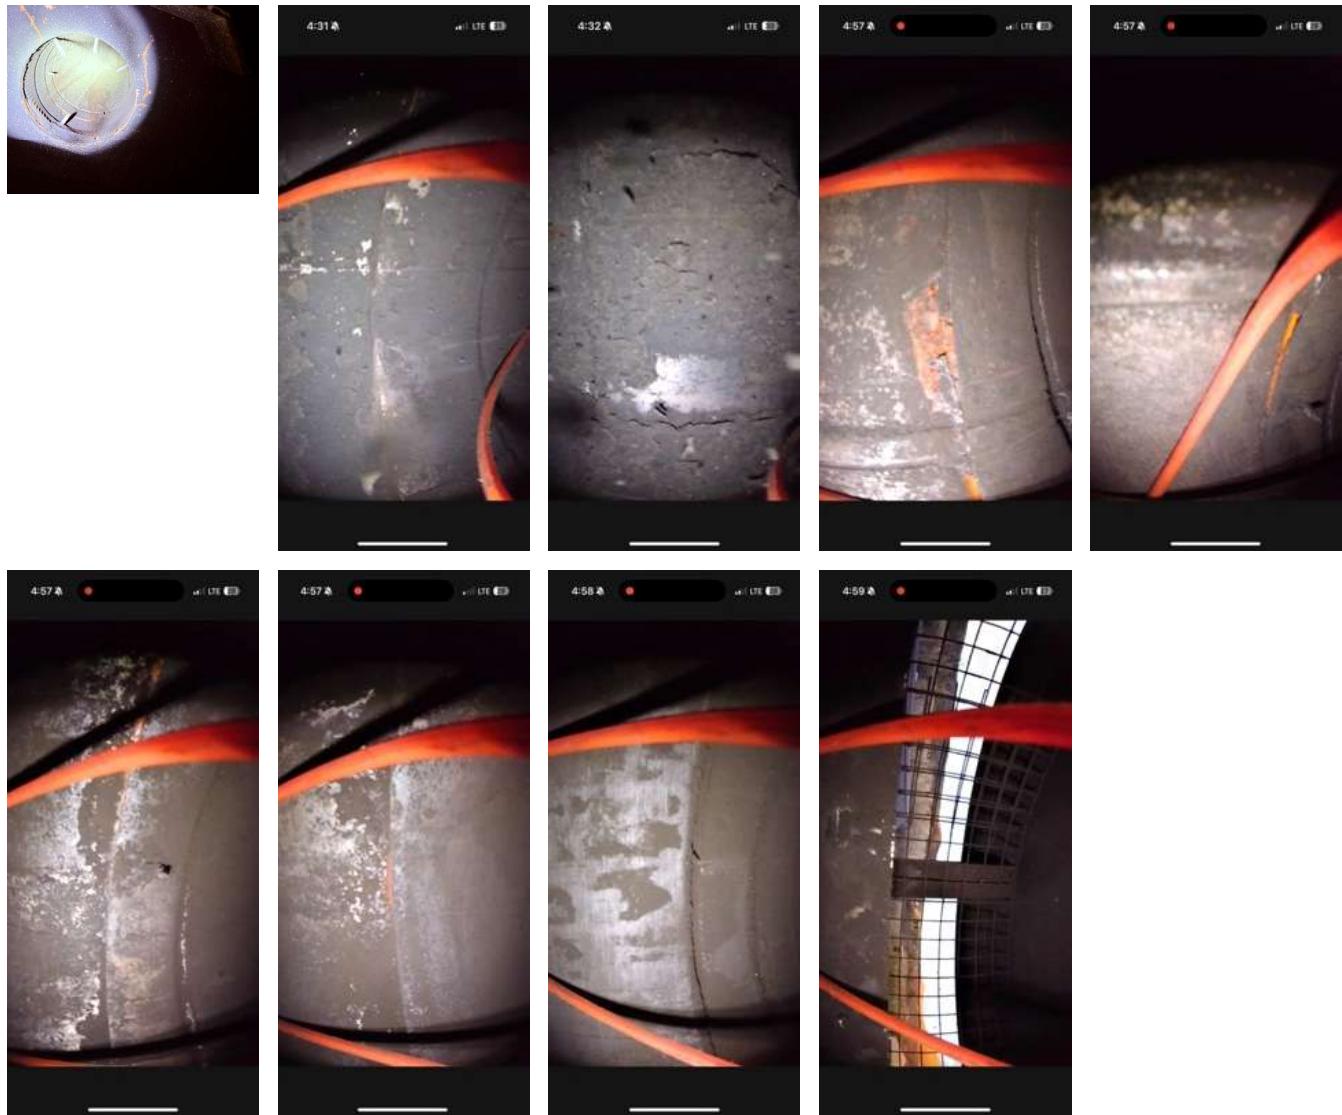
#### Living Room Wood Stove - CHIMNEY, VENT, OR FLUE INTERIOR

#### Factory-Built Chimney, Vent, or Flue Interior: Rusted/corroded

**Explanation:** Deficiencies related to the factory-built flue interior were noted as outlined above. Internal inspections are essential to assess flue integrity and identify hazards such as excessive creosote buildup, deterioration, gaps, or obstructions. Factory-built chimneys and relined systems must be checked for rust, buckling, and seam failures. A compromised flue interior can lead to drafting issues, increased fire risk, or carbon monoxide exposure, making regular inspections critical.

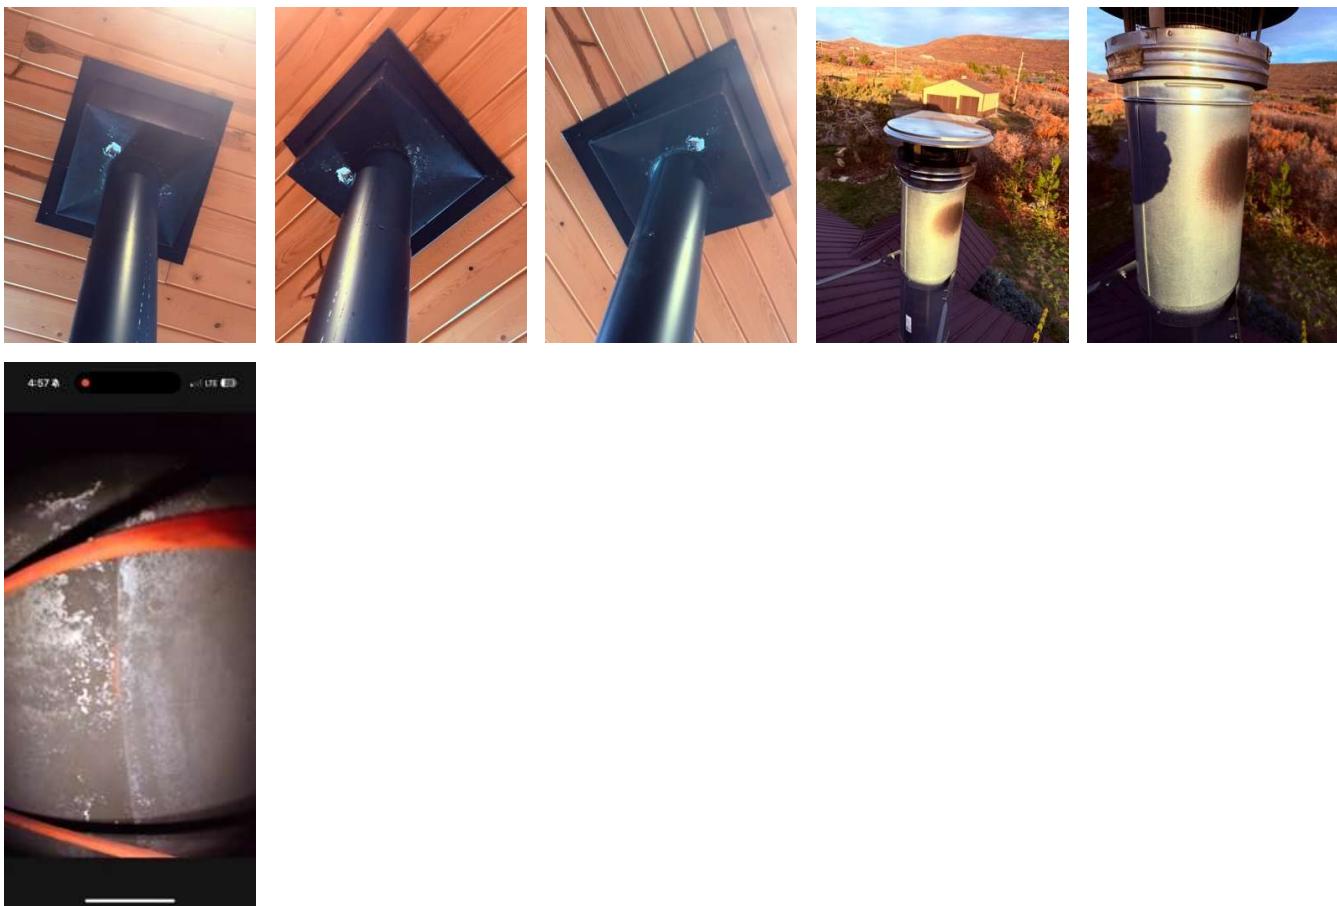
## Living Room Wood Stove - SINGLE SUDDEN OCCURRENCE EVENT

**Single Sudden Occurrence Event:** Discoloration of metal components, Rusted internal chimney/vent

**Explanation:** Evidence of a single sudden occurrence event was noted as outlined above. A single sudden occurrence event, such as a chimney fire, dryer or vent fire, lightning strike, thermal expansion, or physical contact from a falling or colliding object, refers to damage that occurs abruptly and is not consistent with gradual deterioration or wear over time.

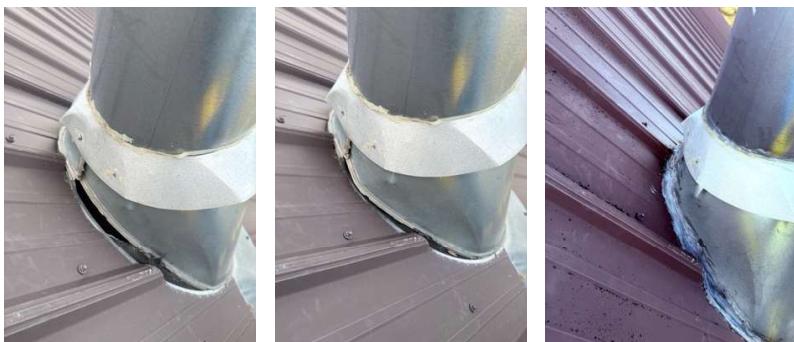
## Living Room Wood Stove - ON-SITE ADJUSTMENT, REPAIR, OR TROUBLESHOOTING

Temporary sealing of broken flashing to keep weather out.

**The following occurred on site (select all that apply):** Adjustment
