The Chimney Doctor | 970-234-3330
2944 I-70 Business Loop #210, Grand Junction, CO 81501
info@chimney.doctor | <https://chimney.doctor/>

SERVICE / INSPECTION REPORT

Address, Cedaredge CO 81413

Type of Work Performed: Repair of Existing System

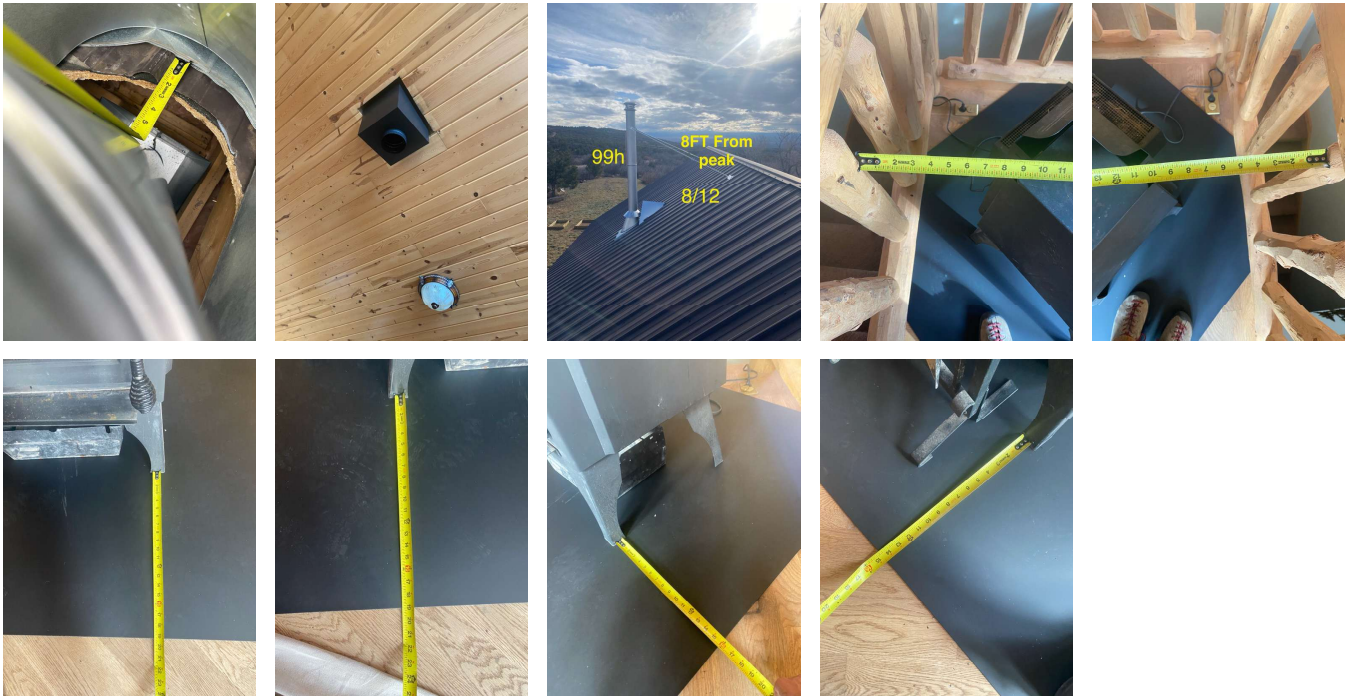
Clearances to combustibles has been met.

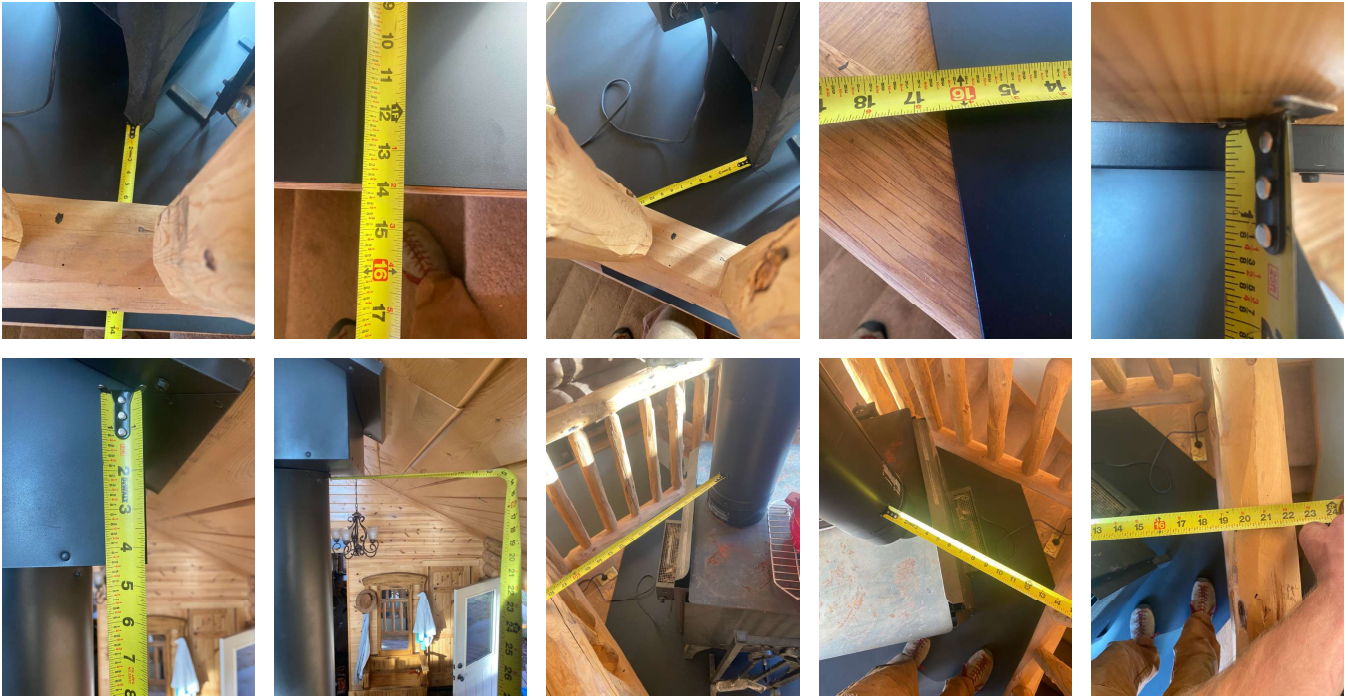
Clearances to combustibles has been met.
