## SERVICE / INSPECTION REPORT

## Fireplace in the Upstairs Bedroom

**Type of Inspection:** Level I Inspection w/ Aspects of a Level II Inspection

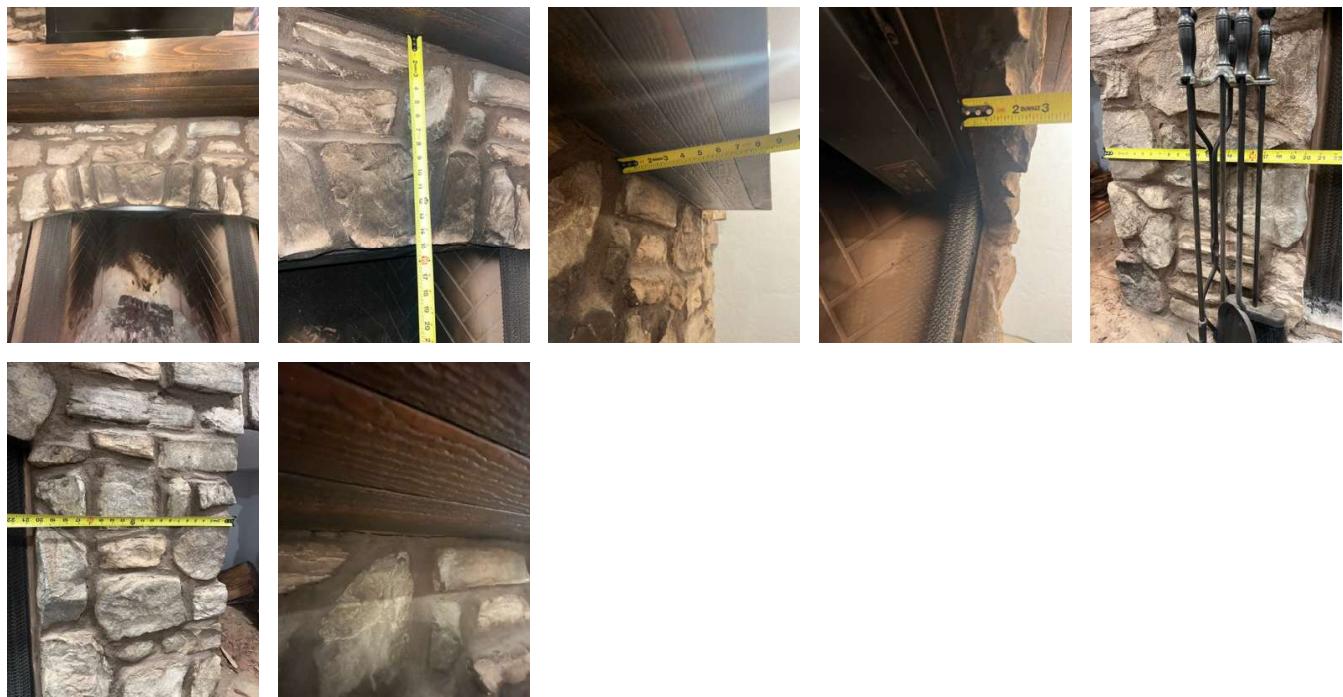
**Fireplace in the Upstairs Bedroom - SURROUND, FACING MATERIALS, AND DIMENSIONS**

**Surround, Facing Materials, and Dimensions:** Nothing to report

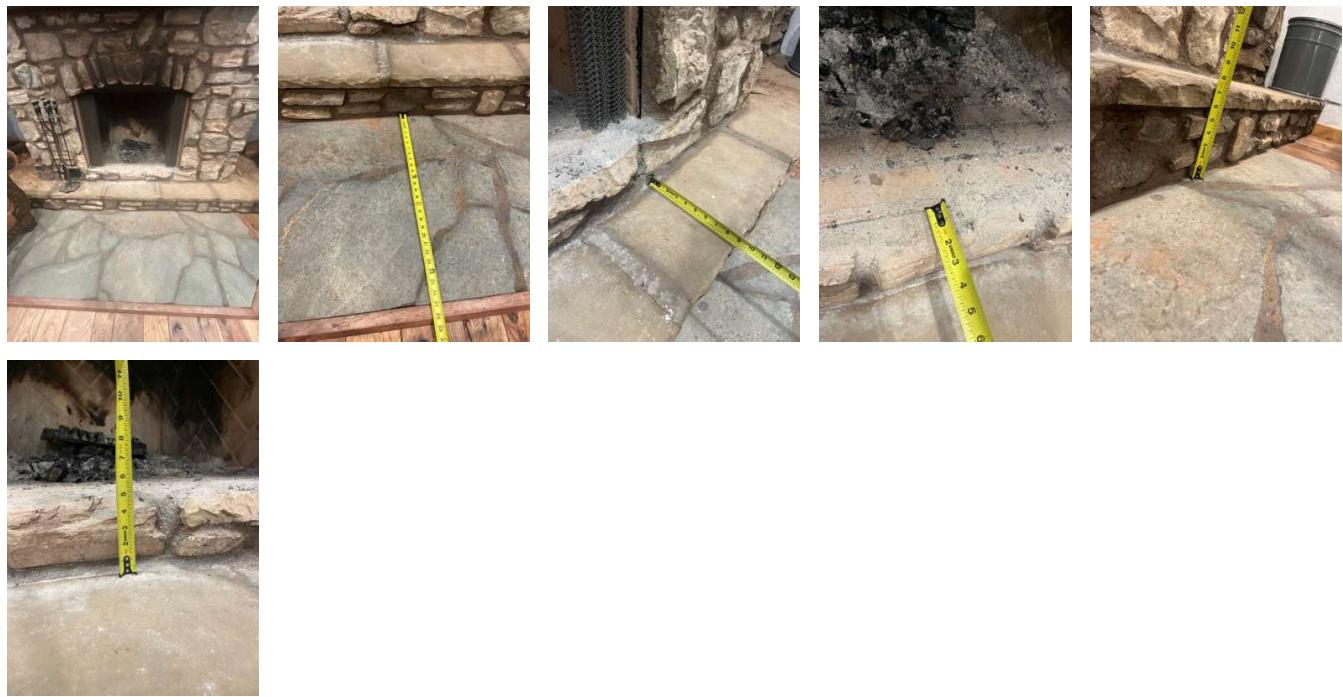
**Fireplace in the Upstairs Bedroom - HEARTH EXTENSION**

**Hearth Extension:** Nothing to report

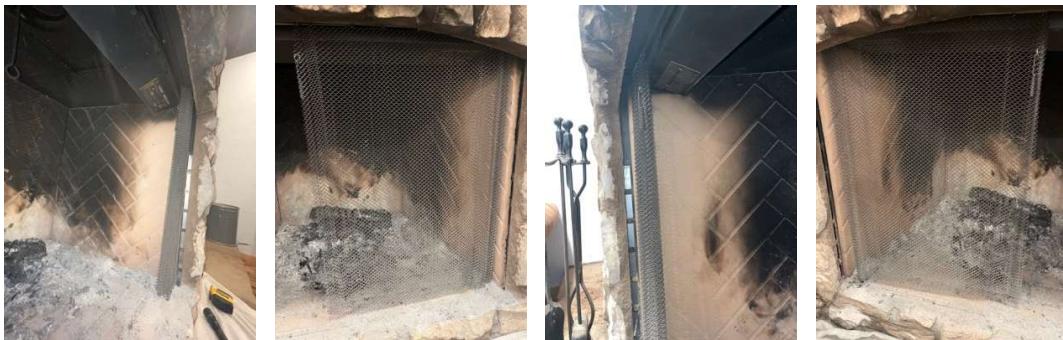
### Fireplace in the Upstairs Bedroom - SCREENS AND GLASS DOORS/ASSEMBLIES

**Screens and Glass Doors/Assemblies:** Nothing to report

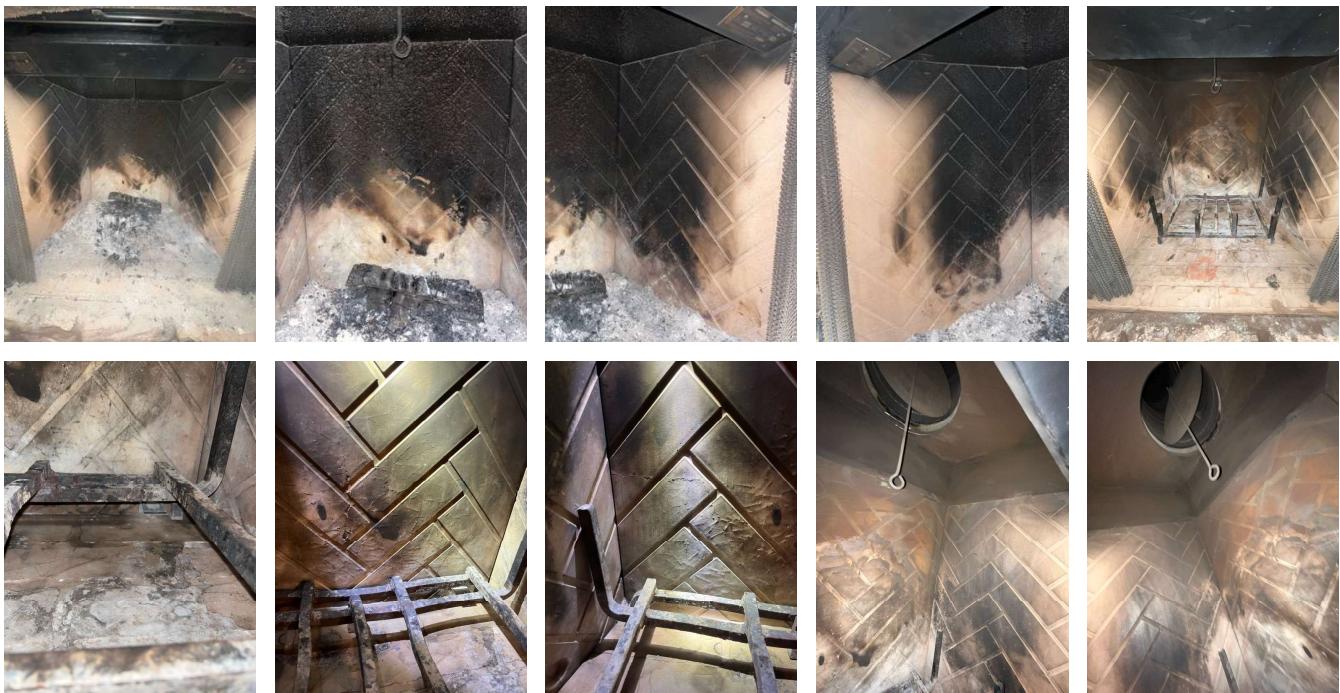
### Fireplace in the Upstairs Bedroom - FIREBOX AND INTERNAL COMPONENTS

**FIREBOX:** Cracking/deterioration of refractory panels.

**Firebox and Internal Components:** Cracking of refractory panels due to use was noted. Replacement recommended.

**Technician Recommendations:** It is recommended that the cracked refractory panels are replaced. Before committing to cost on extension we would recommend verifying the outside air is open and try cracking a window to see if this rectifies the drafting issues during use. If so then issues may be due to insufficient air supply.

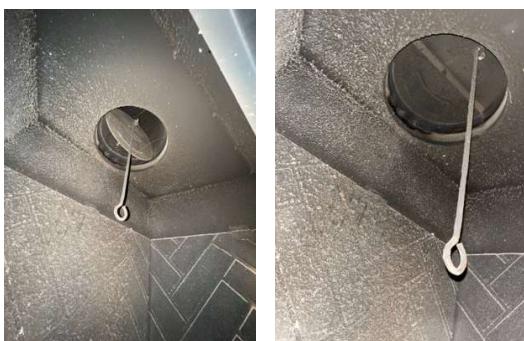
### Fireplace in the Upstairs Bedroom - DAMPERS AND CONTROLS

**Dampers and Controls:** Nothing to report

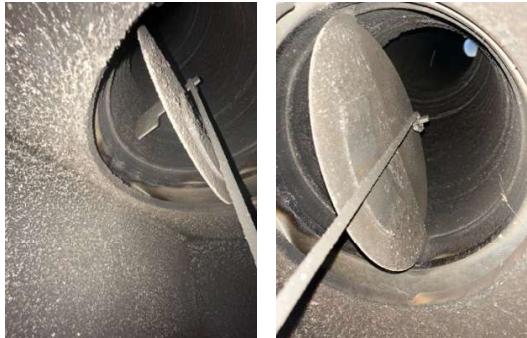
**Fireplace in the Upstairs Bedroom - CONNECTION TO CHIMNEY, VENT, FLUE, OR LINER**

**Connection to Factory-Built Chimney/Vent:** Nothing to report

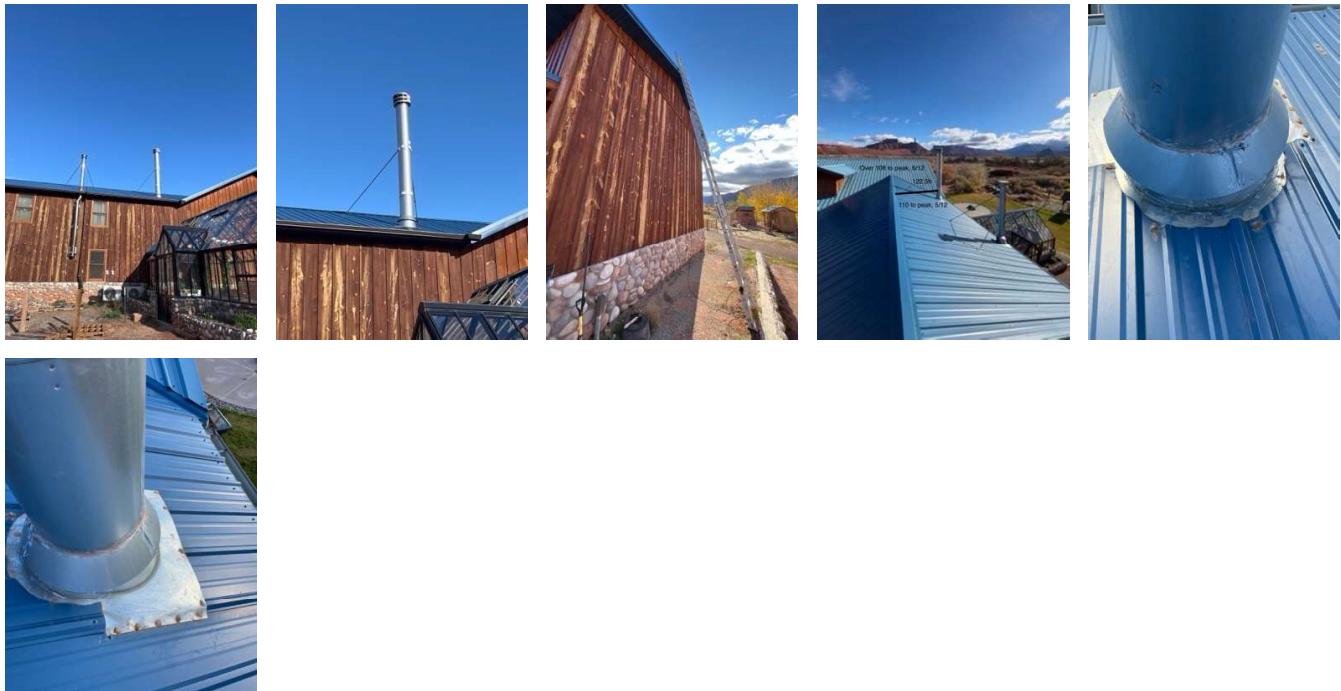
**Fireplace in the Upstairs Bedroom - TERMINATION**

**Factory-Built Termination:** Nothing to Report

As far and the backdraft/drafting concerns spoken about on site, this may be due to what is called the “stack effect” involving other portions of the structure being taller than the chimney itself or insufficient outside air entering the addition to sustain 400 cubic feet of air leaving the structure per minute when the fireplace is in use. As outside air warms up closer to the end of the season draft decreases. Even though the chimney was verified to meet height requirements and no drafting issues were noted during service, a pipe extension may help with this issue.

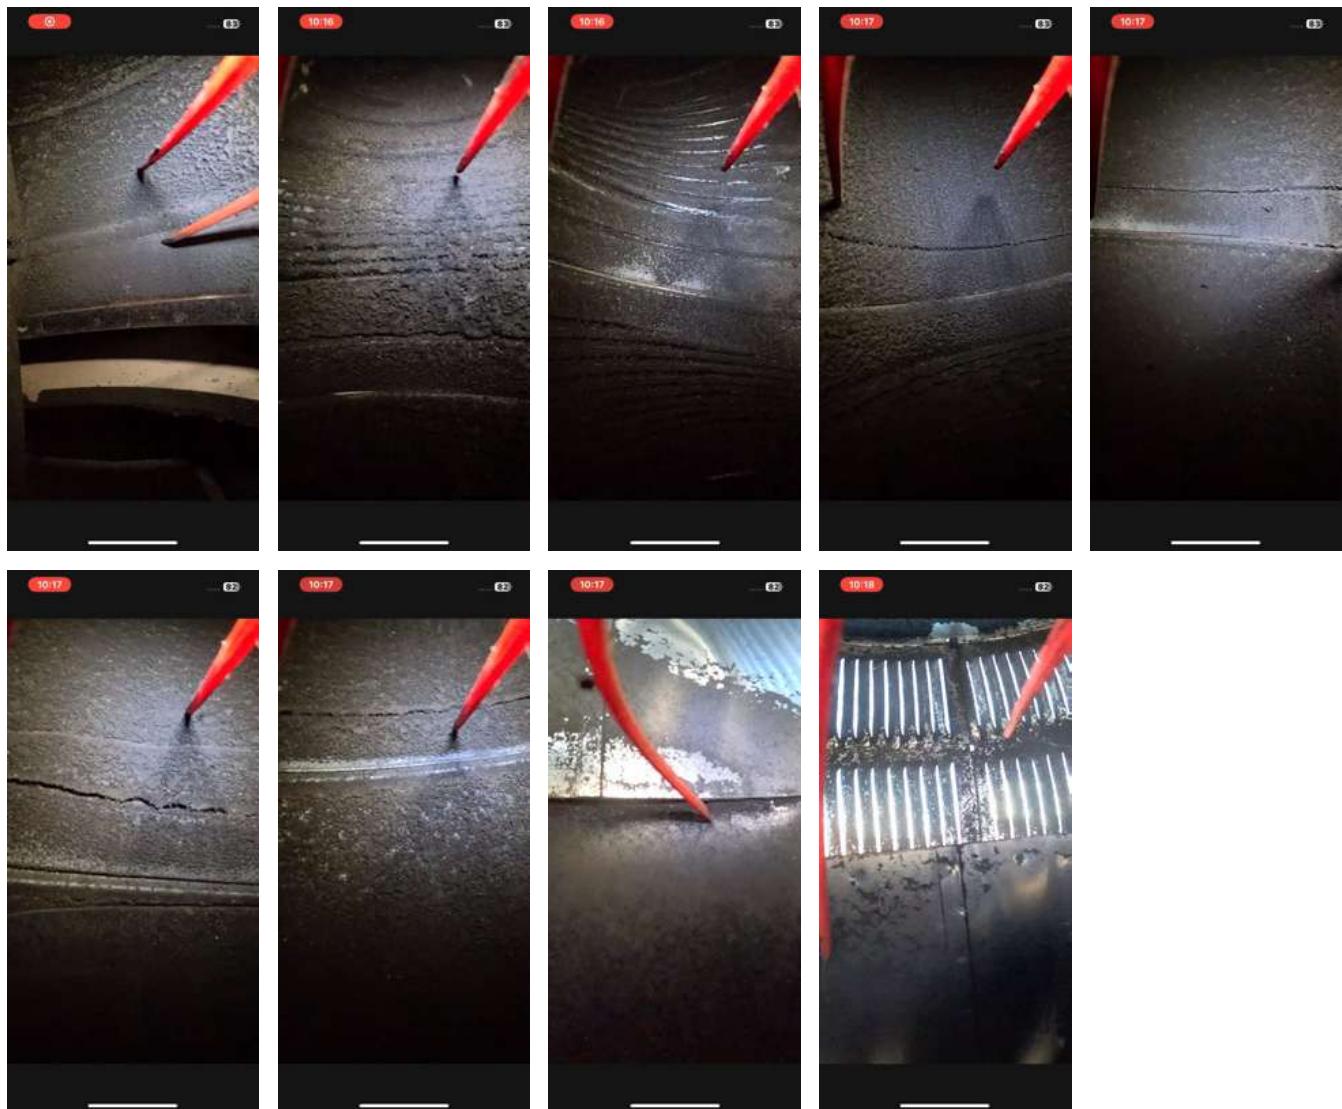
**Fireplace in the Upstairs Bedroom - CHIMNEY, VENT, OR FLUE INTERIOR**

**Factory-Built Chimney, Vent, or Flue Interior:** Nothing to Report
