SERVICE / INSPECTION REPORT

Address, Edwards, Colorado 81632

Fireplace in the Main Level Bedroom

Type of Inspection: Level II Inspection (Accessible Areas)

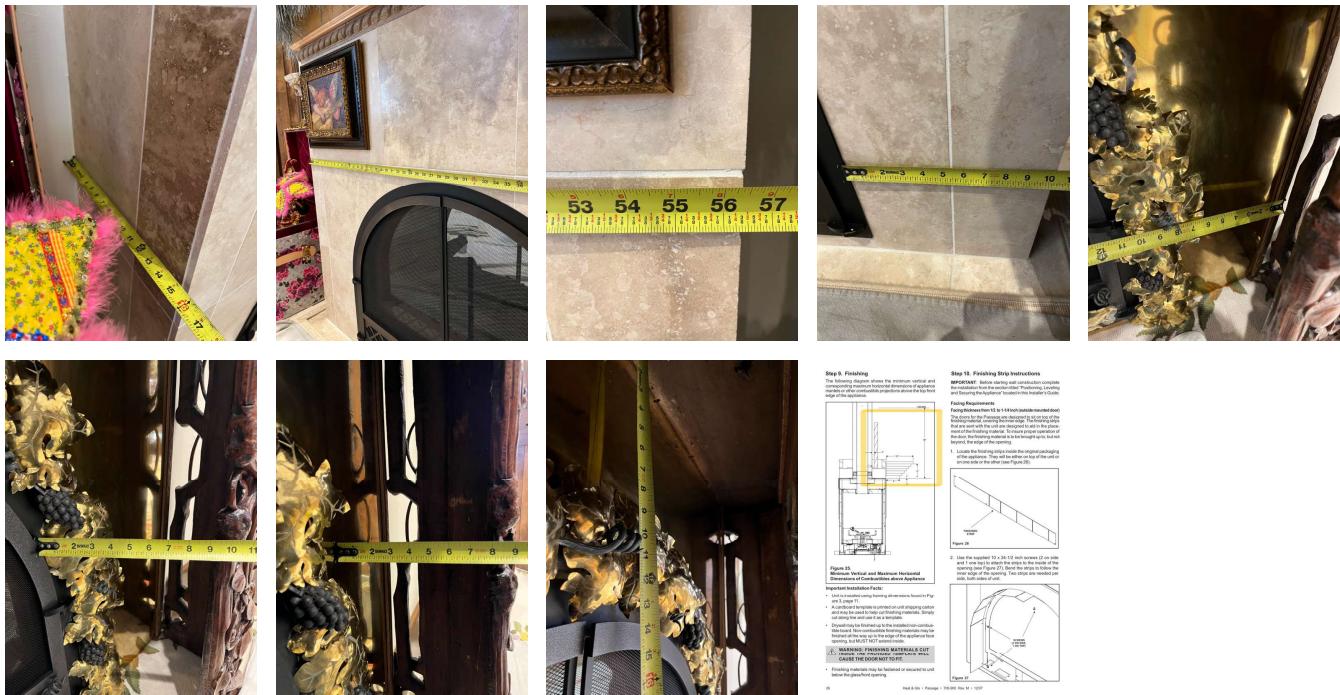
Fireplace in the Main Level Bedroom - SURROUND, FACING MATERIALS, AND DIMENSIONS

Surround, Facing Materials, and Dimensions: Opening clearances NOT met, Other Issue

Explain other issue(s): The unit was able to be accessed inside of the bathroom, but the facing material/decoration obstructed the glass in the bedroom.

Explanation: Deficiencies related to the surround, facing materials, and fireplace dimensions were noted as outlined above. The front of a fireplace can reach extremely high temperatures during operation, requiring specific clearances to prevent overheating of combustible materials. Codes, NFPA 211, and manufacturer specifications for listed fireplaces dictate required distances between the fireplace opening and nearby materials. Some factory-built fireplaces also restrict the projection of non-combustible materials or require non-combustible framing behind them. Improper clearances, gaps, cracks, or insufficient support can lead to heat transfer issues, structural instability, and potential fire hazards. Dimensions not explicitly stated in manufacturer manuals cannot be assumed.

- A) removal or adjustment of the facing material to meet clearances and allow for access to the unit inside of the bedroom
- B) replacement of the damaged logs
- C) extending the chimney to meet height requirements

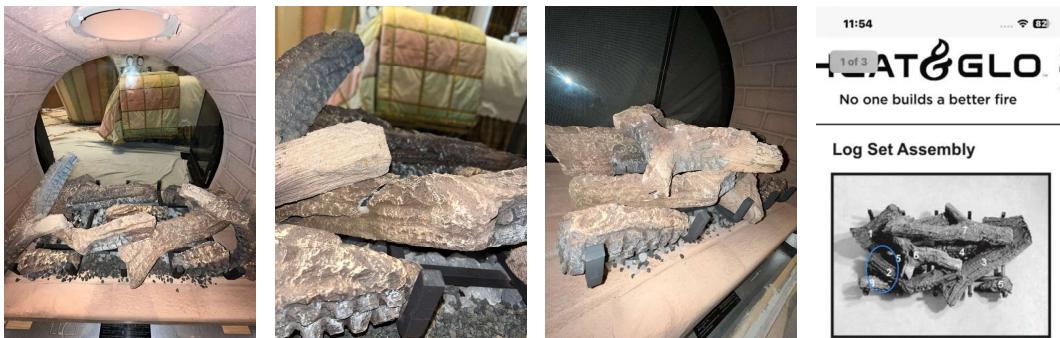
Fireplace in the Main Level Bedroom - GRATES, BURNERS, AND MEDIA

Grates, Burners, and Media: Damaged/deteriorated

Explanation: Deficiencies related to the grate, burner, or media were noted as outlined above. These components support combustion and ensure proper airflow, flame presentation, and media placement in gas or propane appliances. In masonry fireplaces and unlisted modular masonry fireplaces, grates can generally be used unless they contribute to firebox damage. However, listed factory-built fireplaces, modular masonry fireplaces, and hearth/heating appliances must use only grates, burners, or media tested and approved by the manufacturer. Using unapproved components may alter the heat signature of the appliance, create fire hazards, and affect efficiency. Any noted deficiencies may compromise appliance performance and safety, requiring further evaluation.

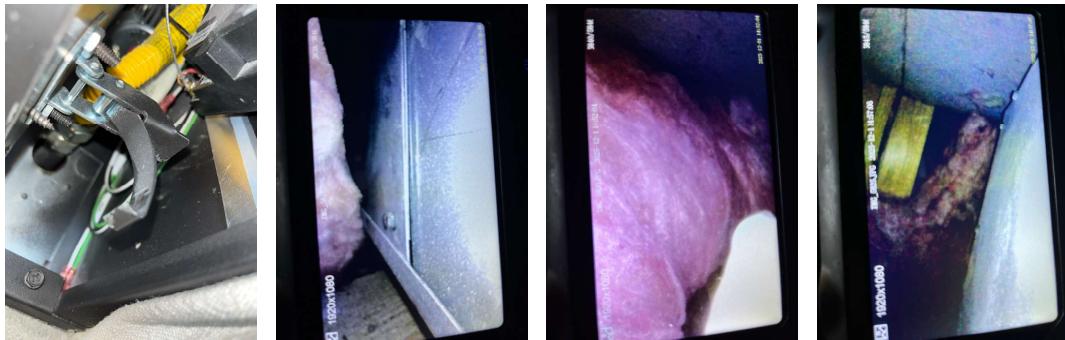
Fireplace in the Upstairs Bedroom - FIREPLACE/APPLIANCE CONCEALED IN CONSTRUCTION

Insulation inside of chase cavity is suspected to be against the unit, but could not verify.

Factory-Built System Concealed in Construction: Unable to determine clearances

Explanation: Deficiencies related to a factory-built system concealed in construction were noted as outlined above. Factory-built fireplaces and certain hearth/heating appliances are designed to be installed behind finished walls or inside chases with specific clearance requirements. Manufacturer instructions dictate the necessary air space between the appliance and surrounding combustible materials, including framing, insulation, and sheathing. Failure to meet required clearances can result in excessive heat transfer, degradation of surrounding materials, or ignition of combustibles. Additional concerns include improper gas line or air intake clearances, moisture or animal entry, and missing protective components such as ember strips or Z-strips, all of which can compromise safety and performance.

- A) the removal or securement of the insulation in the chase
- B) gas line to burner replaced
- C) removal of shroud or chimney extension to terminate above the shroud

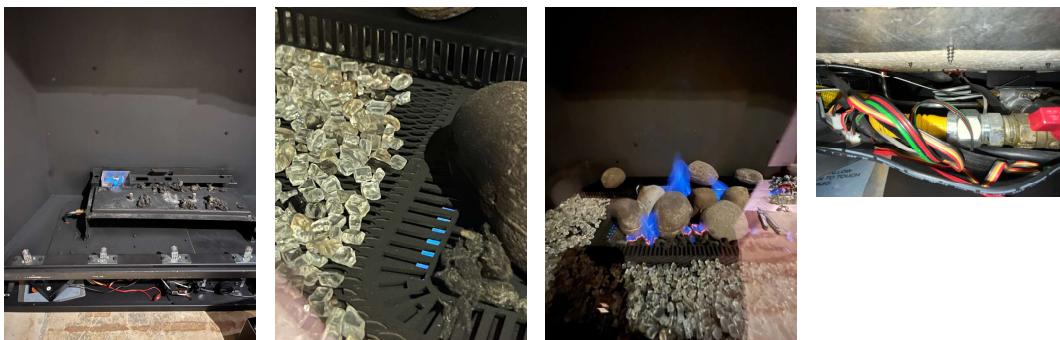
Fireplace in the Upstairs Bedroom - ON-SITE ADJUSTMENT, REPAIR, OR TROUBLESHOOTING

The burner gas line was tightened, as it was noted to be leaking, but this did not correct the issue. Replacement would be necessary to correct this.

The following occurred on site (select all that apply): Repair, Troubleshooting

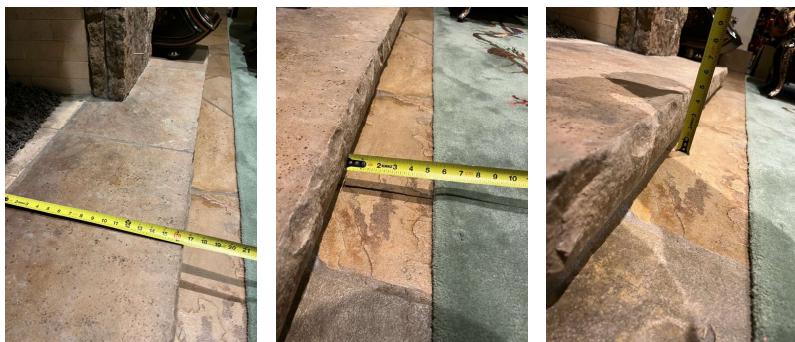
Fireplace in the Main Living Area - HEARTH EXTENSION

Hearth Extension: Insufficient support, Combustibles beneath masonry hearth extension

Explanation: Deficiencies related to the surround, facing materials, and fireplace dimensions were noted as outlined above. The front of a fireplace can reach extremely high temperatures during operation, requiring specific clearances to prevent overheating of combustible materials. Codes, NFPA 211, and manufacturer specifications for listed fireplaces dictate required distances between the fireplace opening and nearby materials. Some factory-built fireplaces also restrict the projection of non-combustible materials or require non-combustible framing behind them. Improper clearances, gaps, cracks, or insufficient support can lead to heat transfer issues, structural instability, and potential fire hazards. Dimensions not explicitly stated in manufacturer manuals cannot be assumed.

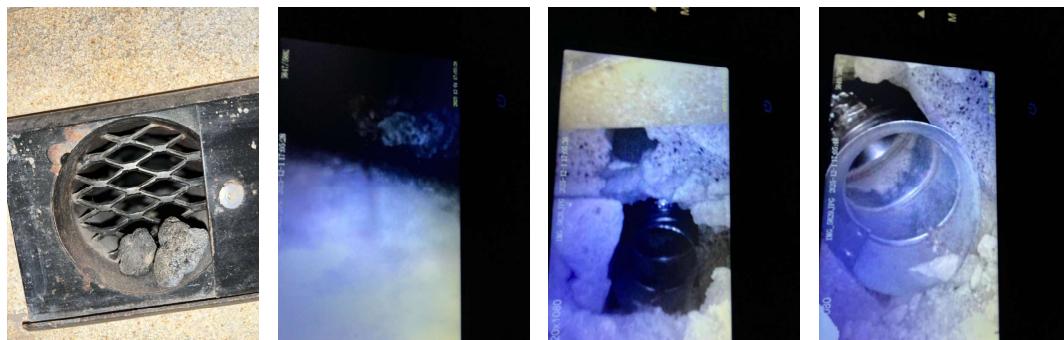
Fireplace in the Main Living Area - COMBUSTION AIR

Combustion Air: Damaged/disconnected

Explanation: Deficiencies related to the combustion air system were noted as outlined above. These systems supply outside air to fireplaces, hearth appliances, furnaces, boilers, or water heaters, reducing indoor air depletion and improving efficiency. The system should be properly connected, constructed of suitable materials, and free of damage, blockages, or disconnections. Terminations must be correctly located to prevent drawing air from prohibited spaces such as crawlspaces, attics, or garages, where contaminants or insufficient airflow could create safety hazards. Signs of heat, soot, or creosote inside the system may indicate improper sealing, air leakage, or backdrafting issues that require further evaluation.

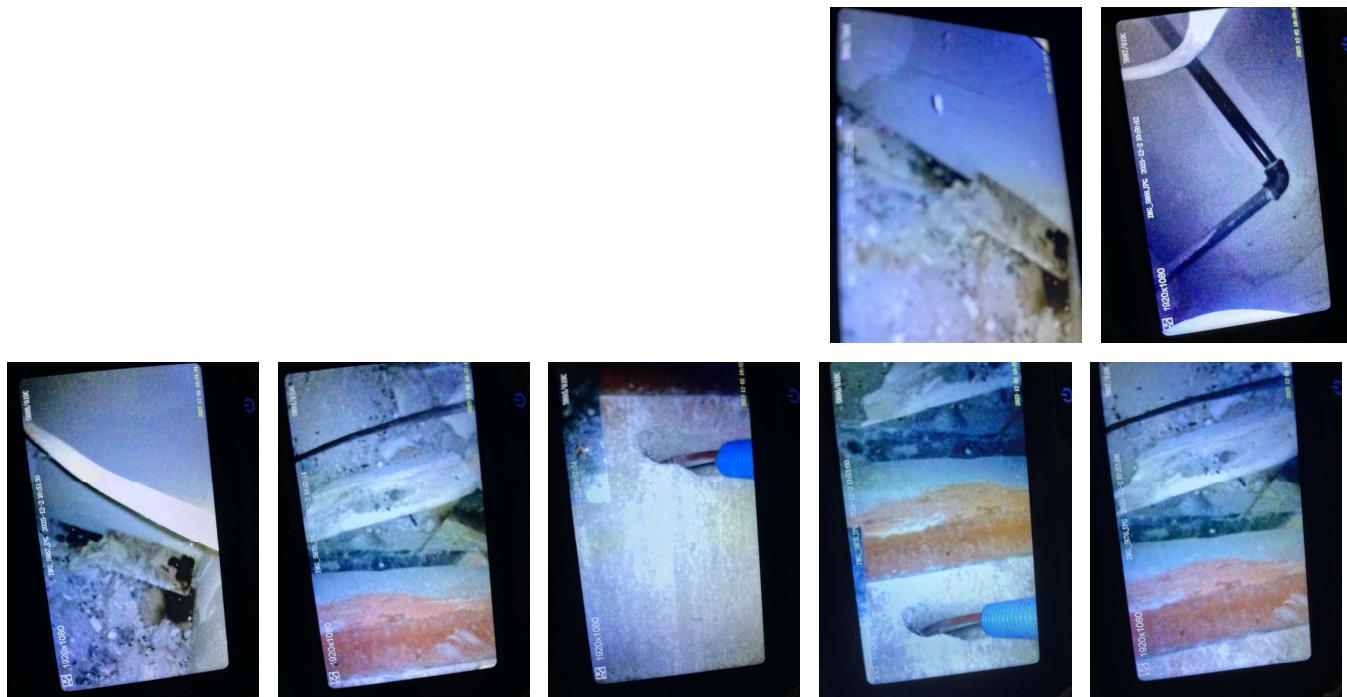
Fireplace in the Kitchen - FIREPLACE/APPLIANCE CONCEALED IN CONSTRUCTION

Factory-Built System Concealed in Construction: Other Issue

Explain other issue(s): Fireplace support is insufficient, as evident based on the control penetration. Masonry support is missing and the unit was installed directly on top of combustion materials.

Explanation: Deficiencies related to a factory-built system concealed in construction were noted as outlined above. Factory-built fireplaces and certain hearth/heating appliances are designed to be installed behind finished walls or inside chases with specific clearance requirements. Manufacturer instructions dictate the necessary air space between the appliance and surrounding combustible materials, including framing, insulation, and sheathing. Failure to meet required clearances can result in excessive heat transfer, degradation of surrounding materials, or ignition of combustibles. Additional concerns include improper gas line or air intake clearances, moisture or animal entry, and missing protective components such as ember strips or Z-strips, all of which can compromise safety and performance.

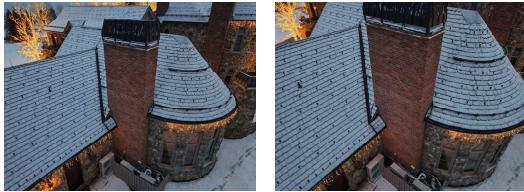
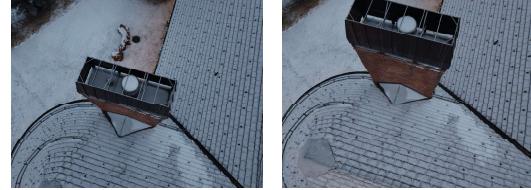
Fireplace in the Kitchen - SHROUDS

Shrouds: Other Issue

Explain other issue(s): The chimney system was unable to be positively identified and a shroud cannot be verified to be suitable for use.

Explanation: Deficiencies related to a shroud were noted as outlined above. Shrouds are sometimes installed at the termination of factory-built chimneys for aesthetic purposes or weather protection. However, they must be listed and approved for use with the specific chimney or fireplace system or constructed per the chimney or fireplace manufacturer instructions. Improperly designed, installed, or constructed shrouds can restrict airflow, trap excessive heat at the termination, and increase the risk of overheating or fire. Manufacturer specifications must be strictly followed to ensure safe operation and to prevent modifications that could negatively affect draft and system performance.
