**The Chimney Doctor Ltd.** | 970-234-3330  
2944 I-70 Business Loop #210, Grand Junction, CO 81501  
info@chimney.doctor | <https://chimney.doctor>

## SERVICE / INSPECTION REPORT

## Dining Room Stove

**Type of Inspection:** Level II Inspection (Accessible Areas)

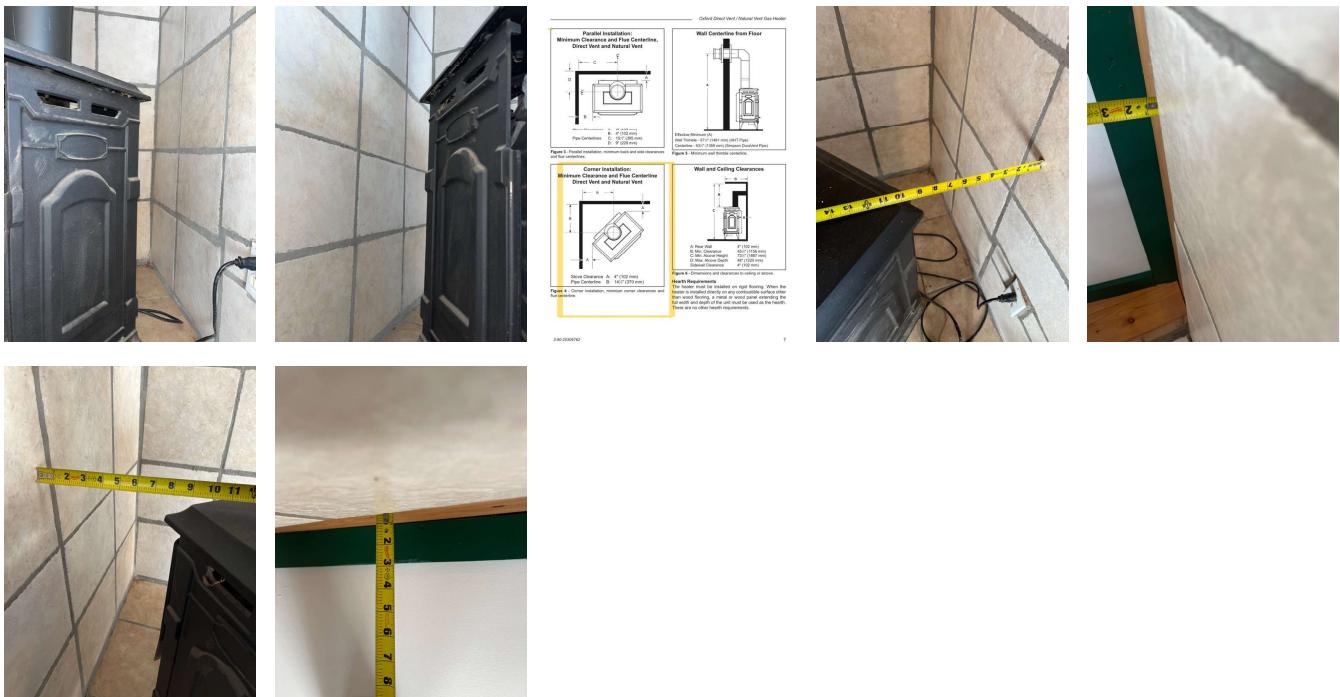
## Dining Room Stove - APPLIANCE CONDITION/CLEARANCES

**Appliance Condition/Clearances:** Nothing to report

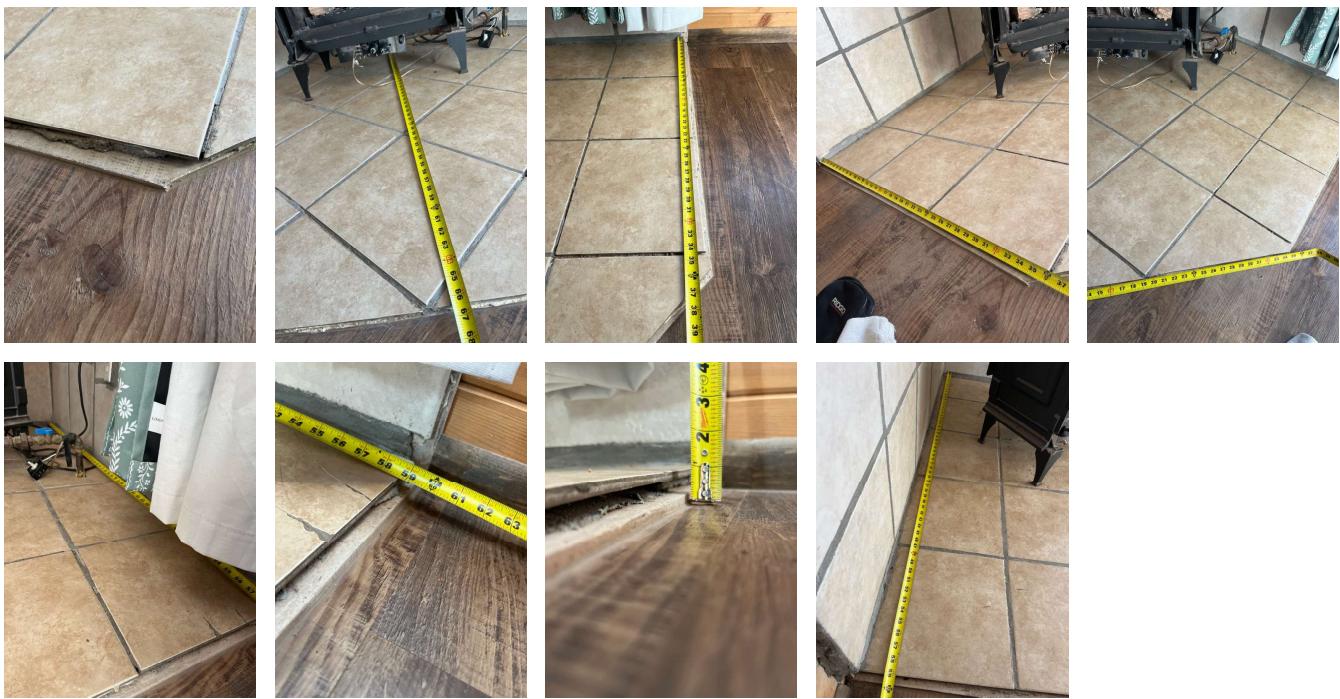
## Dining Room Stove - APPLIANCE FLOOR OR WALL PROTECTION

**Appliance Floor or Wall Protection:** Nothing to report

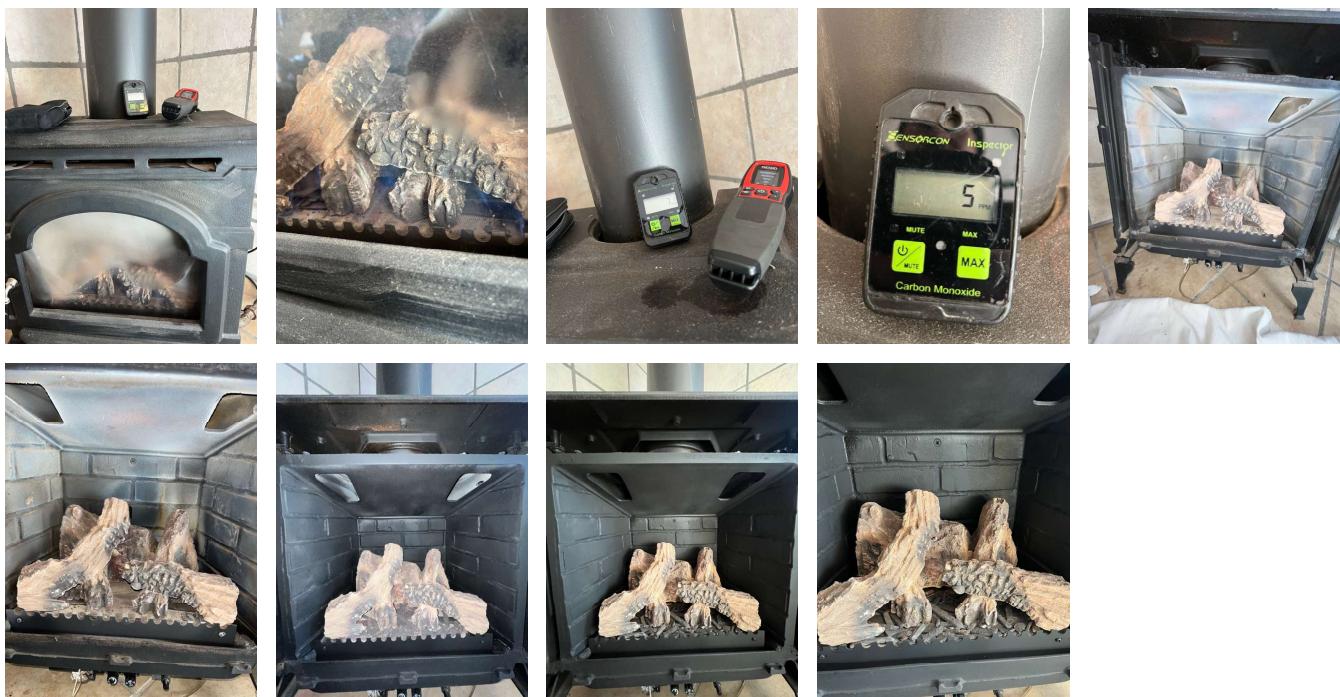
## Dining Room Stove - FIREBOX, INTERNAL COMPONENTS, TEST FIRE

**Firebox and Internal Components:** Nothing to report

**Explanation:** During the arrival test fire conducted prior to adjustment or service; one or more abnormalities were observed involving ignition; pilot operation; burner activation; control response; gas delivery; ignition timing; obstructions; or the presence of a gas or carbon monoxide condition. These observations indicate that the appliance did not operate as intended under initial test conditions. The noted issue(s) were identified before service activities commenced and were used to guide subsequent adjustment; repair; or troubleshooting efforts.

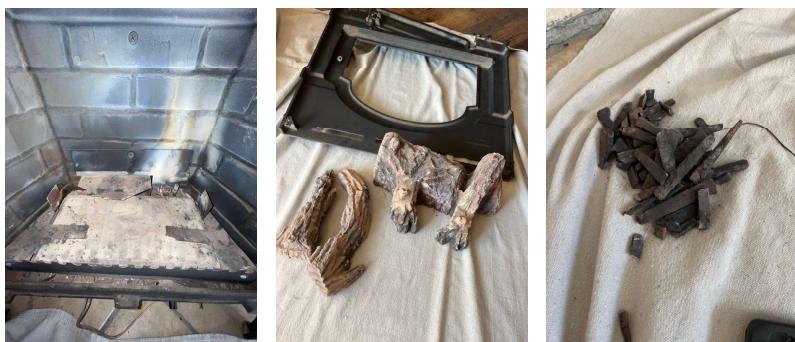
## Dining Room Stove - GRATES, BURNERS, AND MEDIA

**Grates, Burners, and Media:** Nothing to report

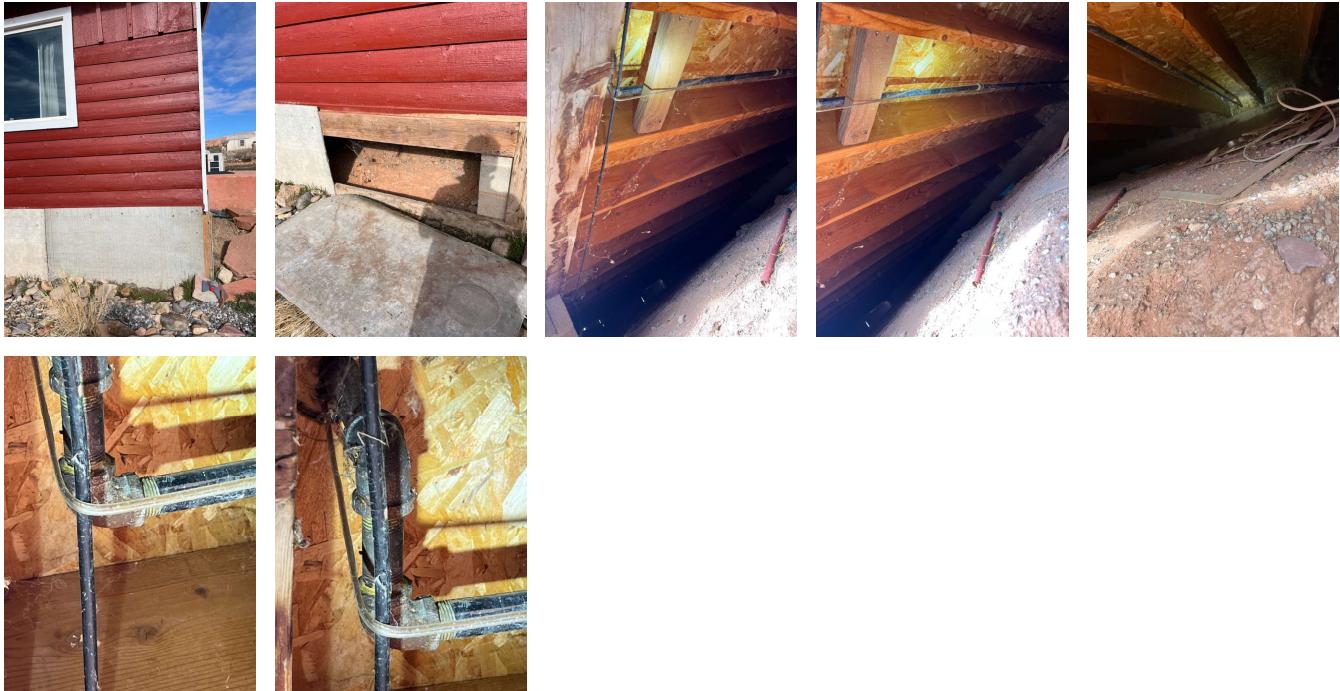
## Dining Room Stove - ADJOINING AREAS ACCESSED

**Adjoining Areas Accessed: Crawlspace**

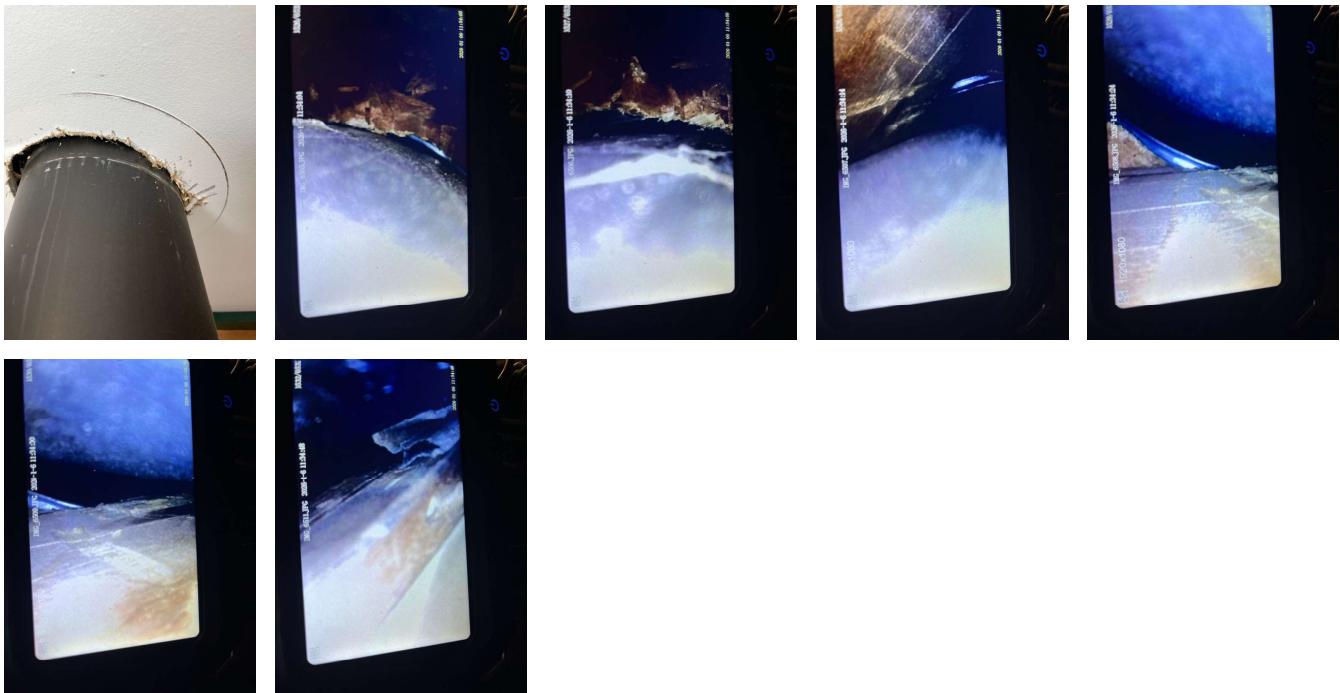
## Dining Room Stove - CHIMNEYS/VENTS IN ADJOINING AREAS

**Factory-Built Chimney/Vent in Adjoining Areas: Clearances NOT met**

**Explanation:** Deficiencies related to a factory-built chimney/vent in adjoining areas were noted as outlined above. Factory-built chimneys and vents require specific clearances to prevent heat buildup, which can degrade or ignite nearby materials. Improper installation, excessive offsets, damaged or improperly installed components components can compromise safety and performance. Clearances must meet manufacturer requirements to maintain system integrity and prevent fire hazards. Failure to comply may void the chimney/vent listing and create risks that could impact both safety and long-term reliability.

**Technician Recommendations:** It is recommended that the system NOT be used until proper repairs are completed. This would include: A) a full chimney replacement B) the required screen installed C) a glass enclosure kit if possible

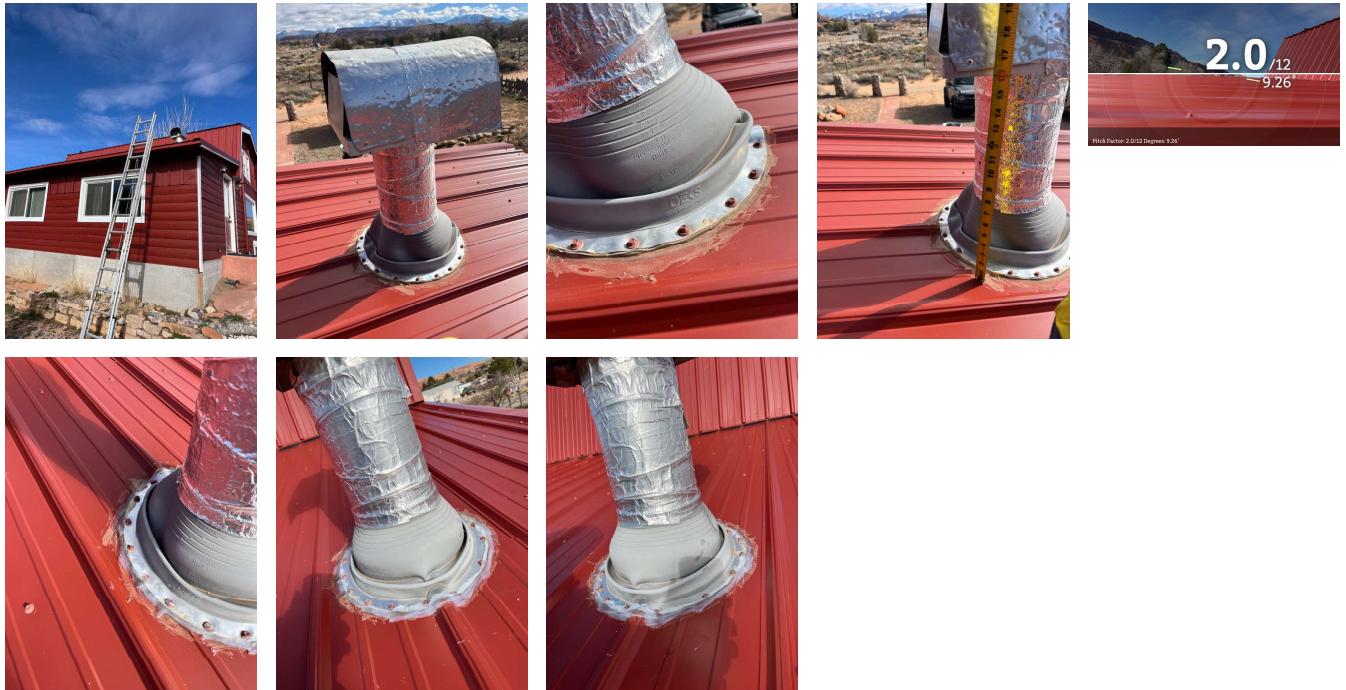
#### Dining Room Stove - TERMINATION

#### Factory-Built Termination: Aftermarket termination/cap

**Explanation:** Deficiencies related to the factory-built chimney/vent termination were noted as outlined above. A proper chimney, vent, or flue termination prevents moisture intrusion, ensures adequate draft, and keeps debris or animals from obstructing the system. Factory-built chimneys/vents may terminate vertically or horizontally depending on the appliance installed and the venting used. Aftermarket, incorrect or missing terminations, rusted or damaged caps, or improper flue sizing can lead to draft failure, moisture damage, and increased fire risks. Air cooled systems that have been compromised can overheat construction elsewhere in the building envelope. A properly installed and maintained termination is critical to the longevity and safety of the venting system.

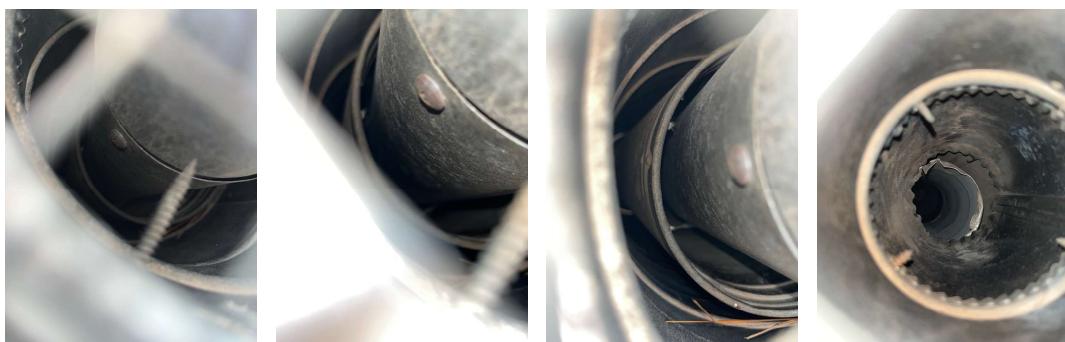
#### Dining Room Stove - CHIMNEY, VENT, OR FLUE INTERIOR

**Factory-Built Chimney, Vent, or Flue Interior:** Damaged/flared seams, Screws penetrate inner liner

**Explanation:** Deficiencies related to the factory-built flue interior were noted as outlined above. Internal inspections are essential to assess flue integrity and identify hazards such as excessive creosote buildup, deterioration, gaps, or obstructions. Factory-built chimneys and relined systems must be checked for rust, buckling, and seam failures. A compromised flue interior can lead to drafting issues, increased fire risk, or carbon monoxide exposure, making regular inspections critical.

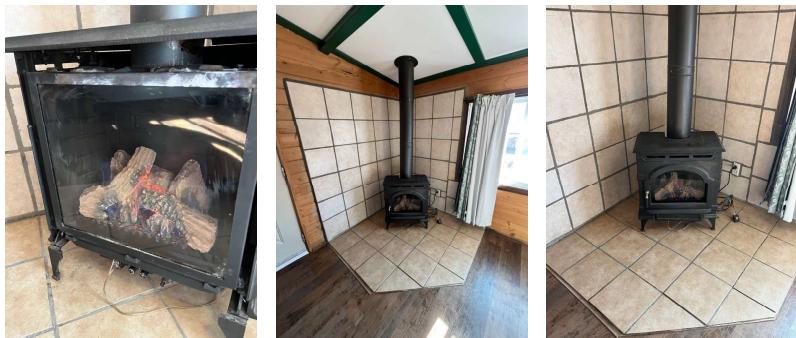
#### Dining Room Stove - ADJUSTMENT, REPAIR, TROUBLESHOOTING, FINAL TEST FIRE

Carbon monoxide leak in house, not from appliance.

**Final Test Fire:** Carbon monoxide (CO) leak detected

**Explain other issue(s):** During the final test fire conducted after adjustment; repair; or troubleshooting; one or more abnormal conditions were observed involving ignition; pilot operation; burner activation; control response; gas delivery; ignition timing; obstructions; or the presence of a gas or carbon monoxide condition. Additional troubleshooting or parts may be required. These observations indicate that the appliance did not operate as intended at the conclusion of service activities. The noted issue(s) reflect conditions present during final operation testing and are documented to accurately represent appliance performance at the time of service completion.
