**The Chimney Doctor Ltd.** | 970-234-3330  
2944 I-70 Business Loop #210, Grand Junction, CO 81501  
info@chimney.doctor | <https://chimney.doctor>

## SERVICE / INSPECTION REPORT

Address, Cedaredge, CO 81413

## Living Room Wood Stove

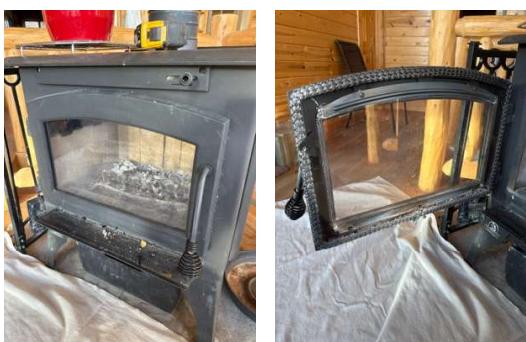
#### Living Room Wood Stove - SCREENS AND GLASS DOORS/ASSEMBLIES

**Screens and Glass Doors/Assemblies:** Nothing to report

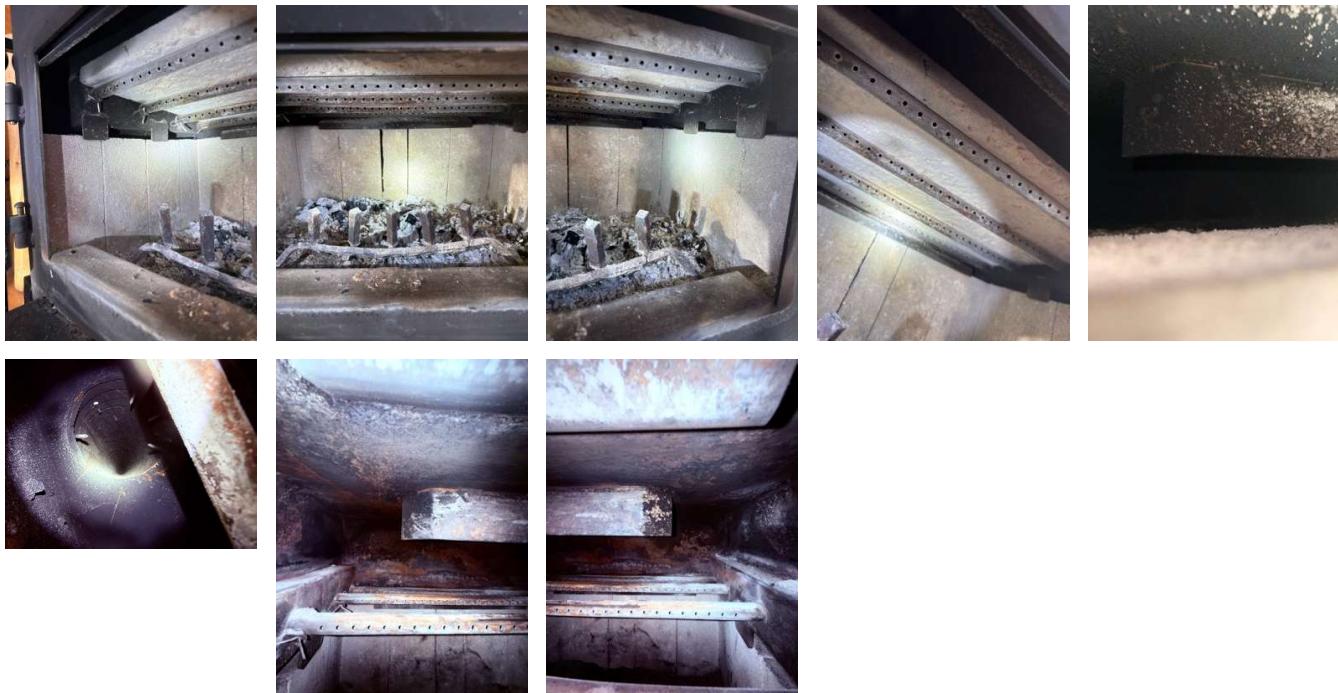
### Living Room Wood Stove - FIREBOX AND INTERNAL COMPONENTS

**Firebox and Internal Components:** Nothing to report
